# LLIS Database Entry: 0448

**Fusing Element Failure resulting from Test Integration, Test, Pyrotechnic Devices, PYRO, Electrical Explosive Devices, EED, Command CIRCUIT, Drive Circuit**

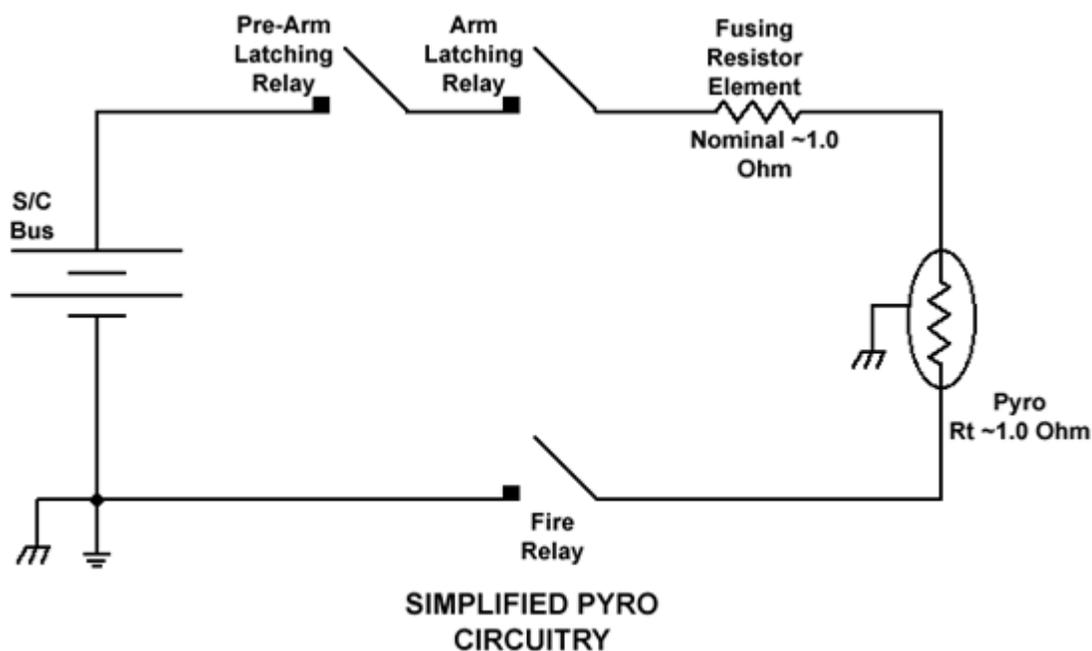
During the tests to verify the resistance value of the EED fusing resistor, it was discovered that in one channel the fusing resistor value was 15 times the required value. Therefore, the fusing resistor would no longer activate a flight installed EED. When the assembly was opened, the resistor was found to be charred. Evidence points to this being a result of EED firing via a ground pulse and the EED establishing an internal path to ground that resulted in a sustained current until the pre-arm/arm path was interrupted by fusing resistor failure.

The mechanism for the damage appears to be the ground firing pulse combined with the known effect of EED shorting to case during discharge. The enclosed figure is a simplified diagram of the ground firing pulse configuration. The prearm and arm contacts are closed or opened by ground command for extended periods. The duration of positive voltage application is mostly dependent upon intervening operations. However, a minimum duration on the order of a few hundred milliseconds would be expected from the contractor's implementation.

The fire pulse is a 40 ms ground activation pulse. If the prearm and arm commands are executed, the EED only needs the fire pulse ground connection to initiate. Once the fire pulse occurs then a "sneak" **CIRCUIT** can occur internal to the EED by either the bridge wire shorting to the EED case or by a low resistance plasma path to the case (information seems to indicate that this kind event occurs in about 4 percent of EEDs). If this happens, high current will flow until either the fusing resistor opens or the prearm or arm functions are deactivated.

A short duration fire pulse on the positive voltage side would not have caused fusing resistor damage. If the fire pulse were placed on the positive side of the **CIRCUIT** instead of the ground side a high surge current could still occur but only for the duration of the 40ms fire pulse instead of the much longer duration of the prearm and arm relays.

An obvious recommendation is that the status of the fusing element be verified after the last EED live fire test, before launch, which would stress the fusing element. Another recommendation would be NOT TO USE THIS DESIGN. If it is desired to break all connections to the power source then this could be done with an arm and a prearm single pole elements in each leg of the design or with double pole elements. Best of all options would be to not use this kind of ground fire pulse design AND check the status of fusing element after each use of the **CIRCUIT** and prior to launch. It is crucial that for any designs like that shown the fusing element be checked at least once before launch and after the last test that would stress the fusing element.
