MPR-SAT-63-1  
January 8, 1963

SATURN SA-3 FLIGHT EVALUATION

VOLUME I

By Saturn Flight Evaluation Working Group

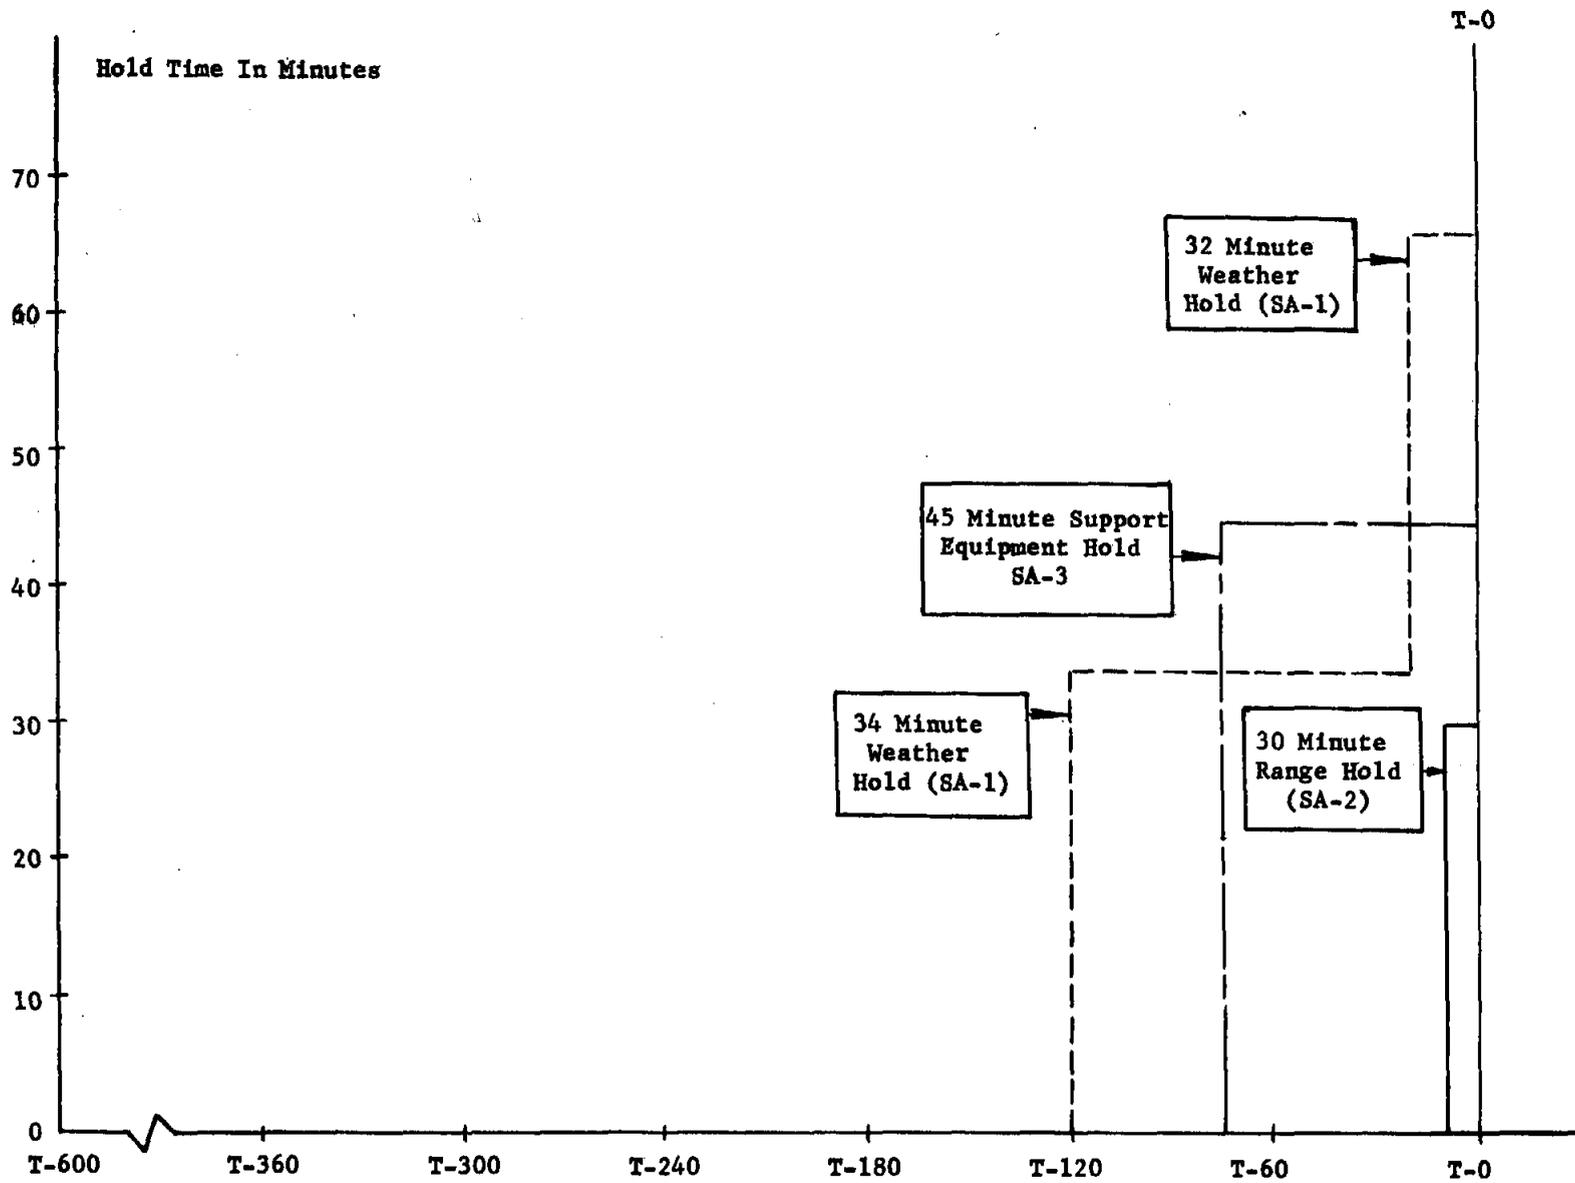
FIGURE 3-1 COUNTDOWN TIME IN MINUTES

Launch countdown began at T-600 minutes at 0200 EST on November 16, 1962 and was continuous except for one 45-minute hold caused by ground generator power failure at T-75 minutes (Figure 3-1). Network generator number 2 dropped out, apparently due to the over-voltage sensing circuit, causing the hold. The nominal value for activation of the over-voltage device is 37 volts; however, it was found that the over-voltage sensing device for this generator had shifted to 35 volts (approximately the terminal voltage of the generator at the moment of dropout). The sensing device was replaced. The over-voltage bypass circuits for all generators (normally energized at "LOX bubbling complete") were then jumpered for the remainder of the countdown to avoid further difficulties in this area. The count was resumed at 1130 hours EST and continued until launch.

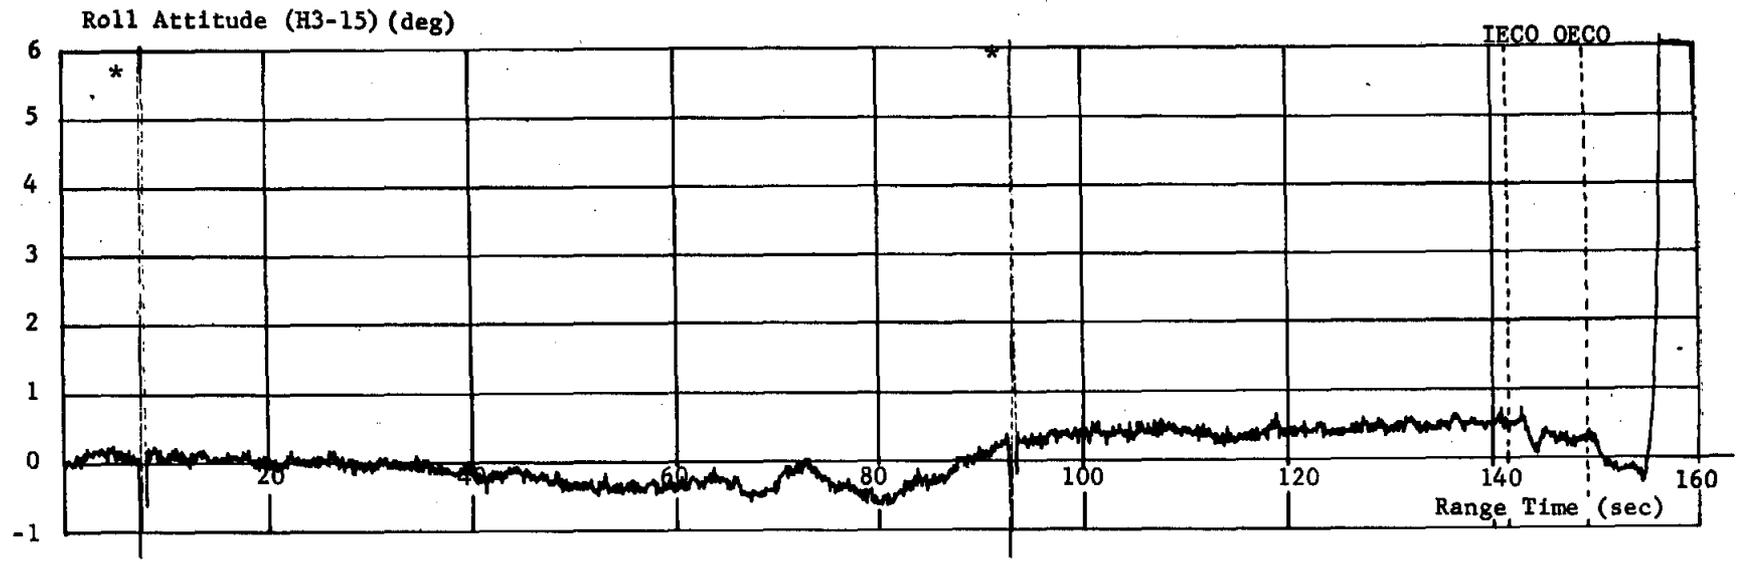
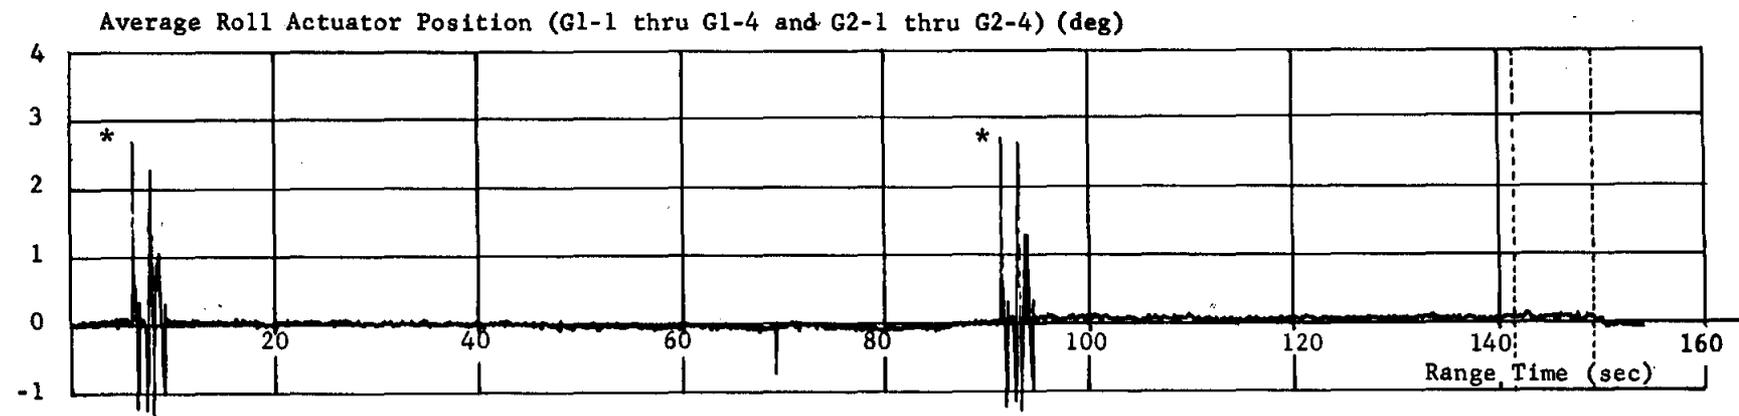
FIGURE 7-7 ROLL ATTITUDE AND AVERAGE ACTUATOR POSITIONS

The roll deviation clearly does not affect the functional performance of the vehicle, but analysis will be pursued further from a general interest viewpoint.

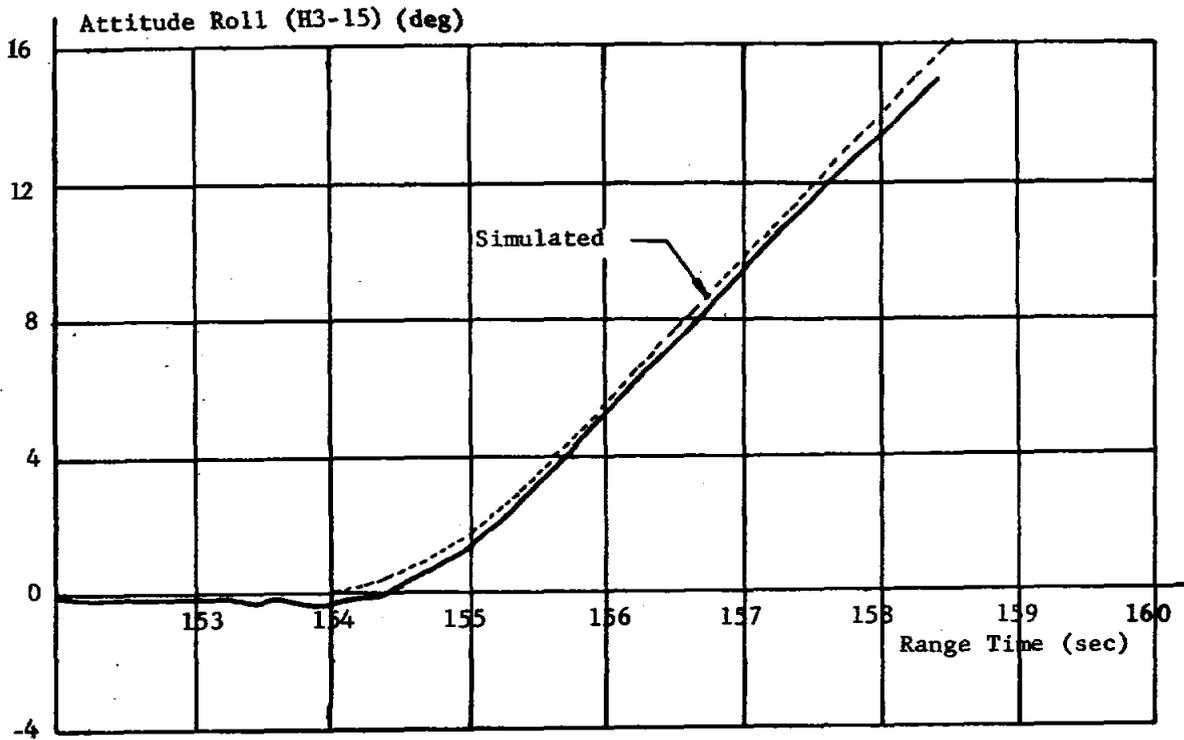
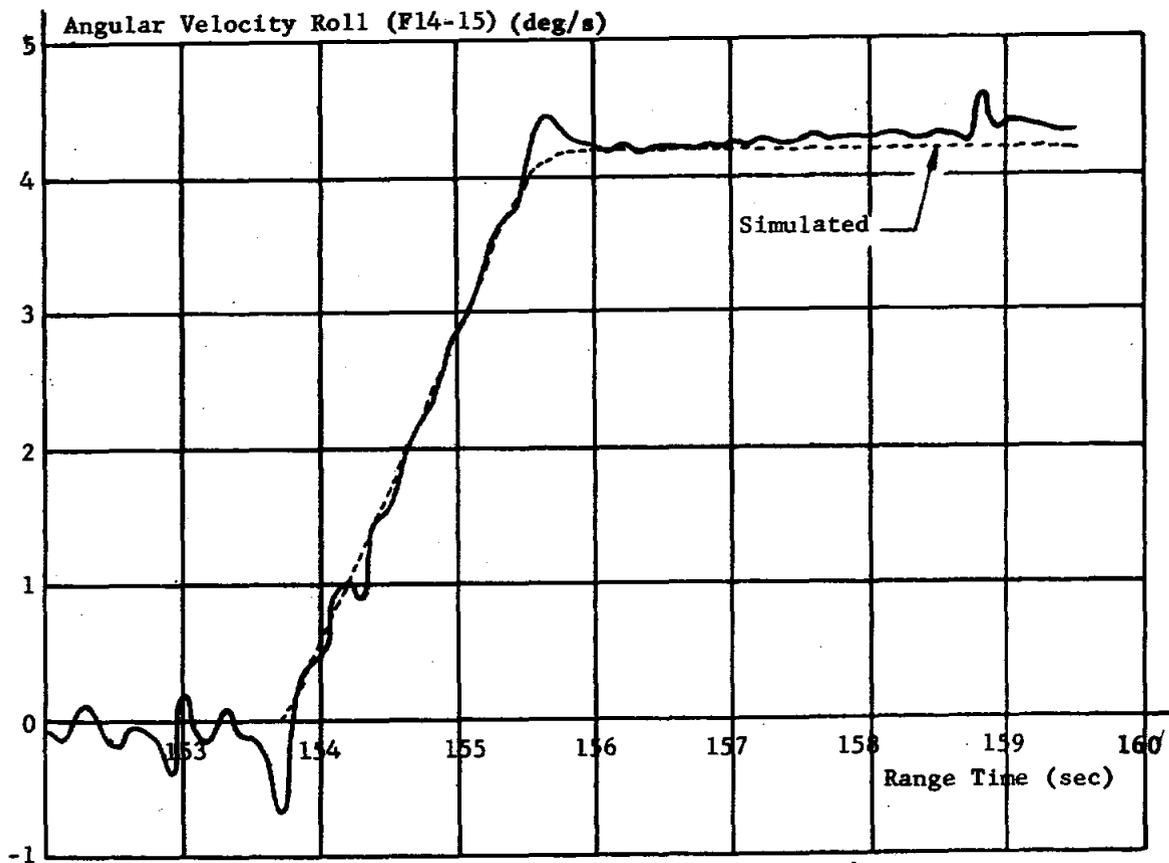
FIGURE 7-9 ROLL DURING RETRO ROCKET FIRING

During retro rocket operation, a vehicle roll (clockwise viewed from the rear) of approximately 4.3 deg/s occurred and is attributed to a retro rocket misalignment of approximately 0.3 deg for each rocket.

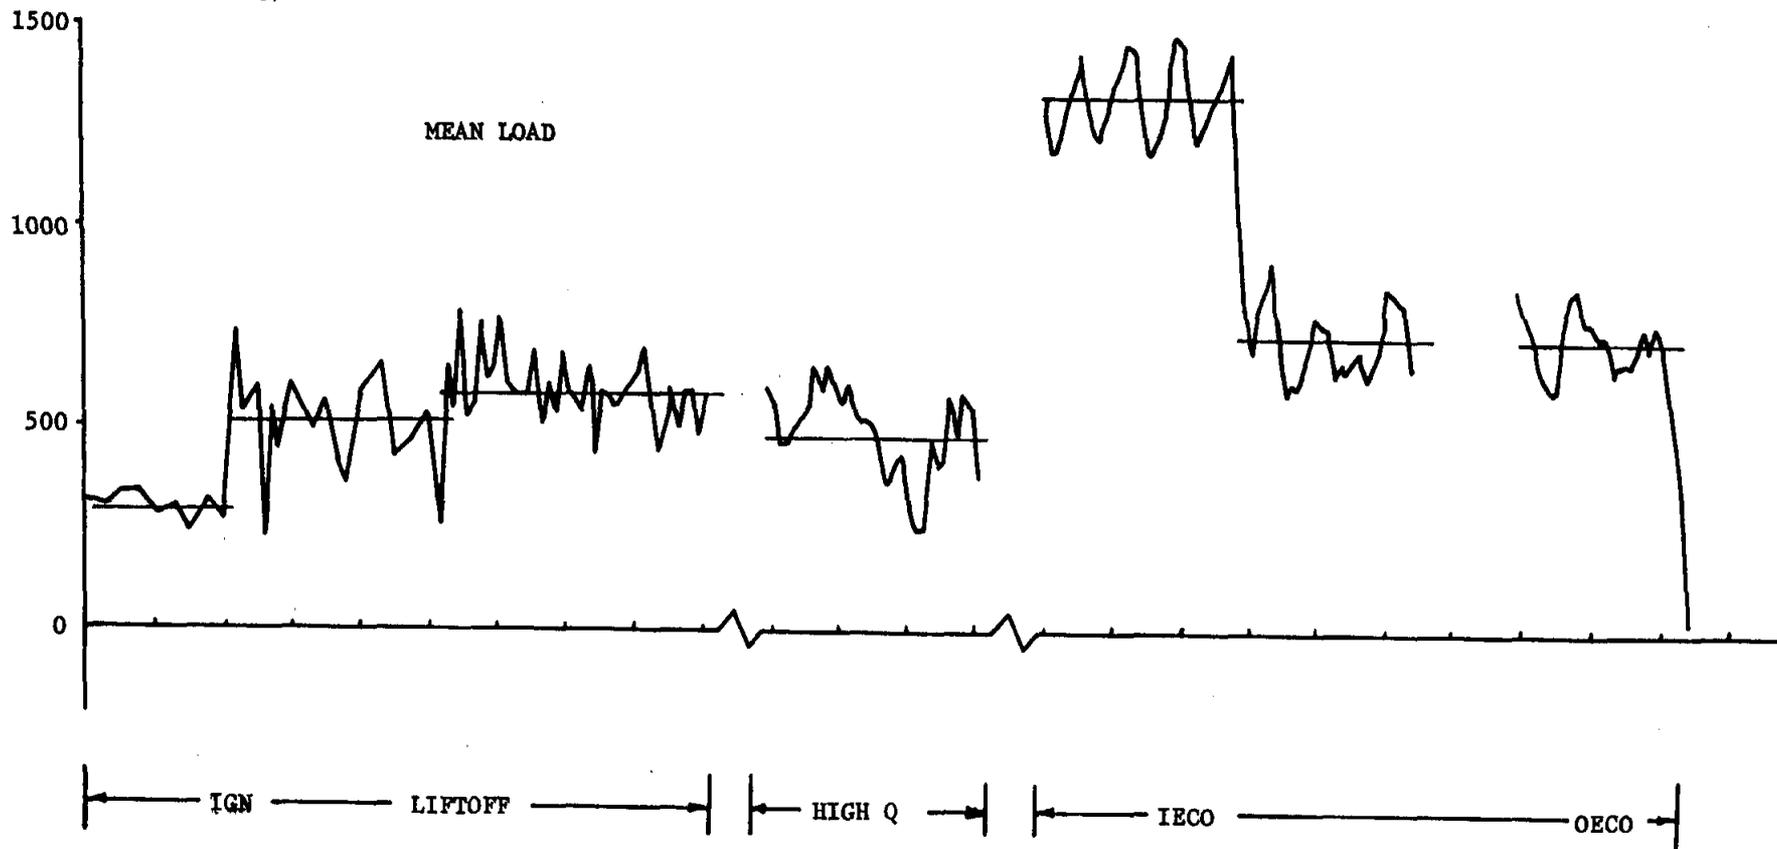
FIGURE 7-12 REPRESENTATIVE ACTUATOR LOADS

The differential pressure measurements indicate maximum actuator loads of 1,433 kg (design load 5,230 kg) occurred just prior to in-board engine cutoff (see Figure 7-12). Variable loads up to 689 kg appeared during the high dynamic pressure region of flight. The center of gravity of each of the outboard engines is displaced radially from the engine center line approximately 20 cm primarily due to the turbo-pump assembly. The increasing acceleration of the vehicle, coupled with this offset center of gravity location, puts a load on each of the engines tending to swing them outboard. The increase in actuator loads to counteract this inertial load can readily be observed in the vector diagram in the lower portion of Figure 7-13. The maximum inertial loading occurred just prior to IECO and was 970 kg. Gravitational loading effects prior to liftoff are not clearly indicated since curtain loads and the exact zero point of the  $\Delta P$  measurements interfere with the determination.

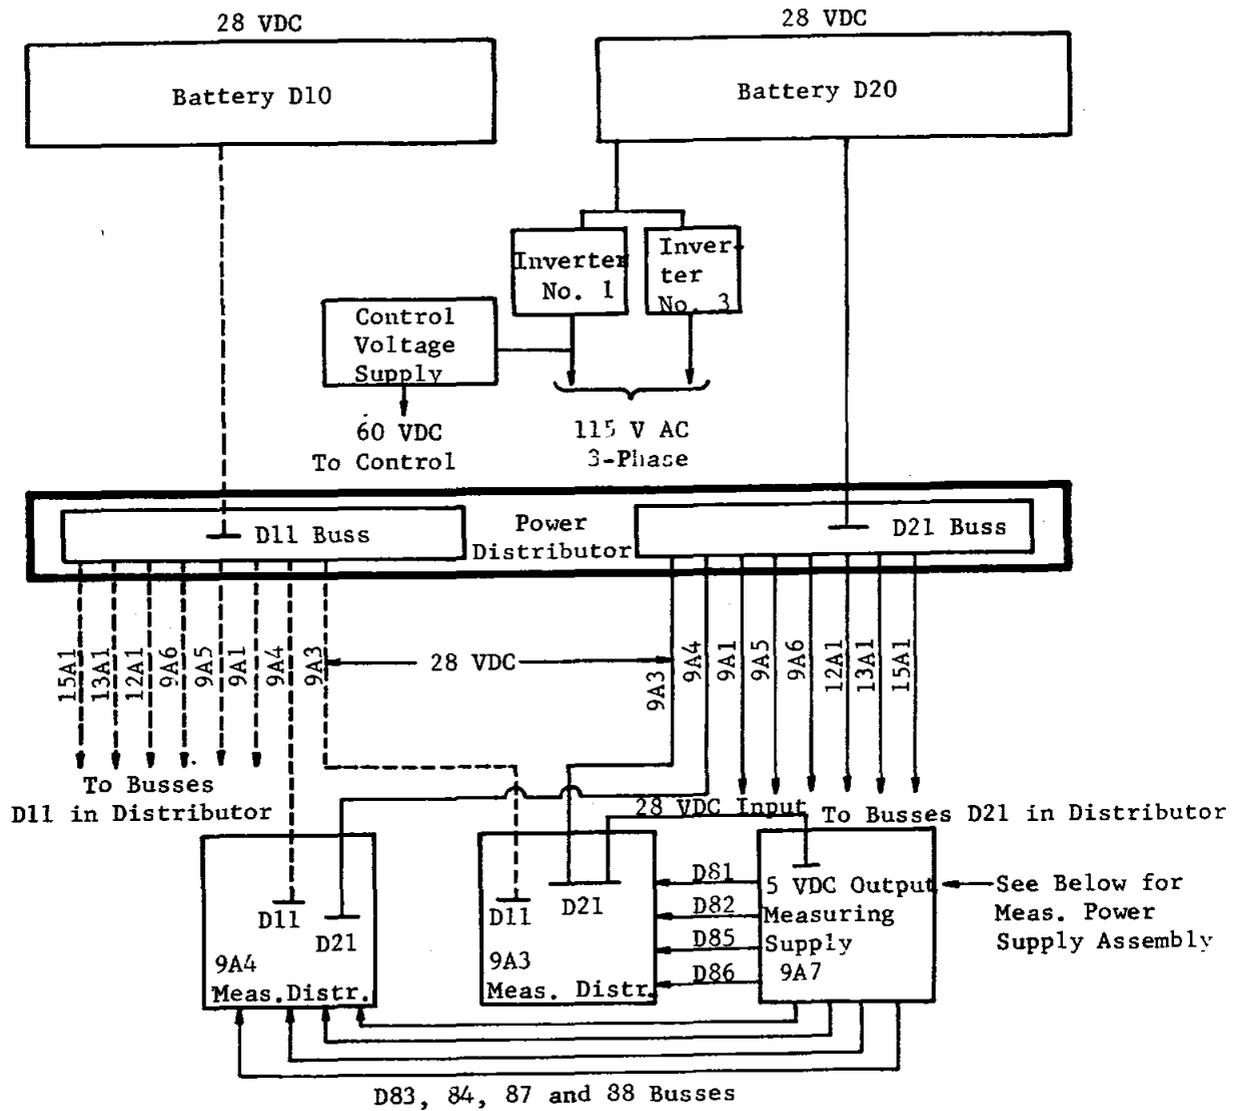
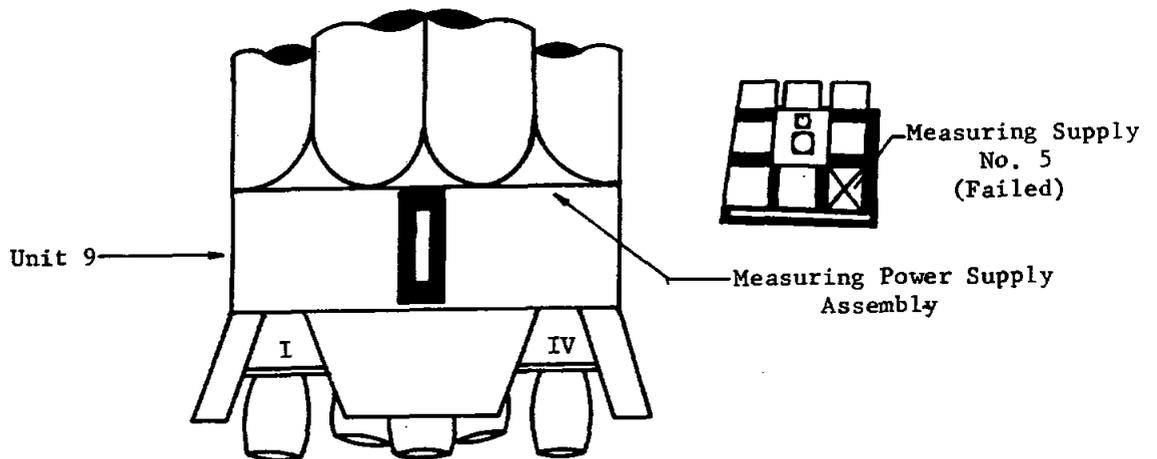
FIGURE 9-1 DISTRIBUTOR CONNECTIONS AND UNIT 9 MEASURING SUPPLY

The measuring voltage supply assembly has a volume of approximately 208 cu. in., weighs 7.05 pounds, and is located in the thrust frame area of the vehicle, above the firewall (see Figure 9-1). The assembly consists of eight individually isolated power supplies and one input filter. Each power supply contains seven transistors. Five of the seven transistors were ultra-high-reliability type transistors obtained through Engineering Magnetics from Pacific Semi Conductors Incorporated.

The two remaining transistors consisted of one Fairchild type and one Texas Instrument type. Shaker tests indicate that the Pacific Semi Conductors type (EM 13531) transistor was the probable cause of failure in measuring voltage supply number 5. Additional tests are being conducted to determine more detailed information. However, this type of transistor will be replaced on SA-4.
