# INVESTIGATION OF DSC TRANSISTOR FAILURES

Orbiter/02-14-02

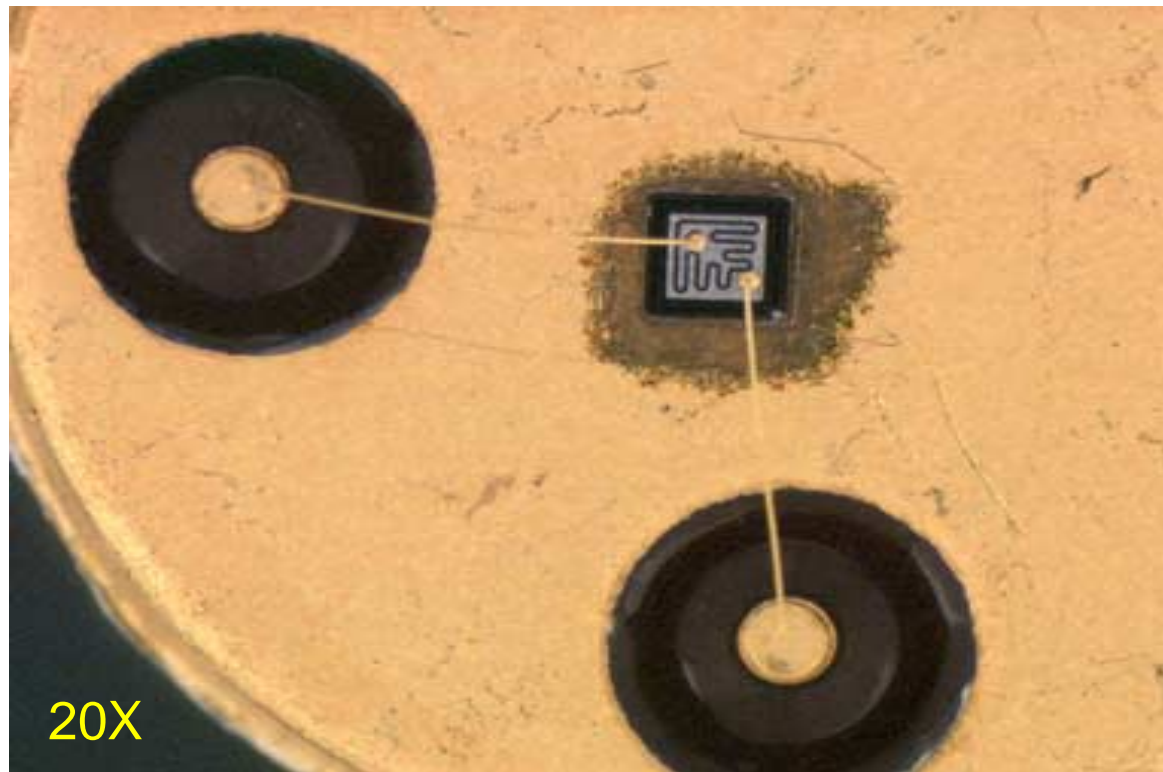
Figure 1

- The DSC CVRD module Q503 transistor failures (detached base and emitter bond wires) are illustrated in Figures 1 through 4

### Bond Wires Appear to be Attached to Die

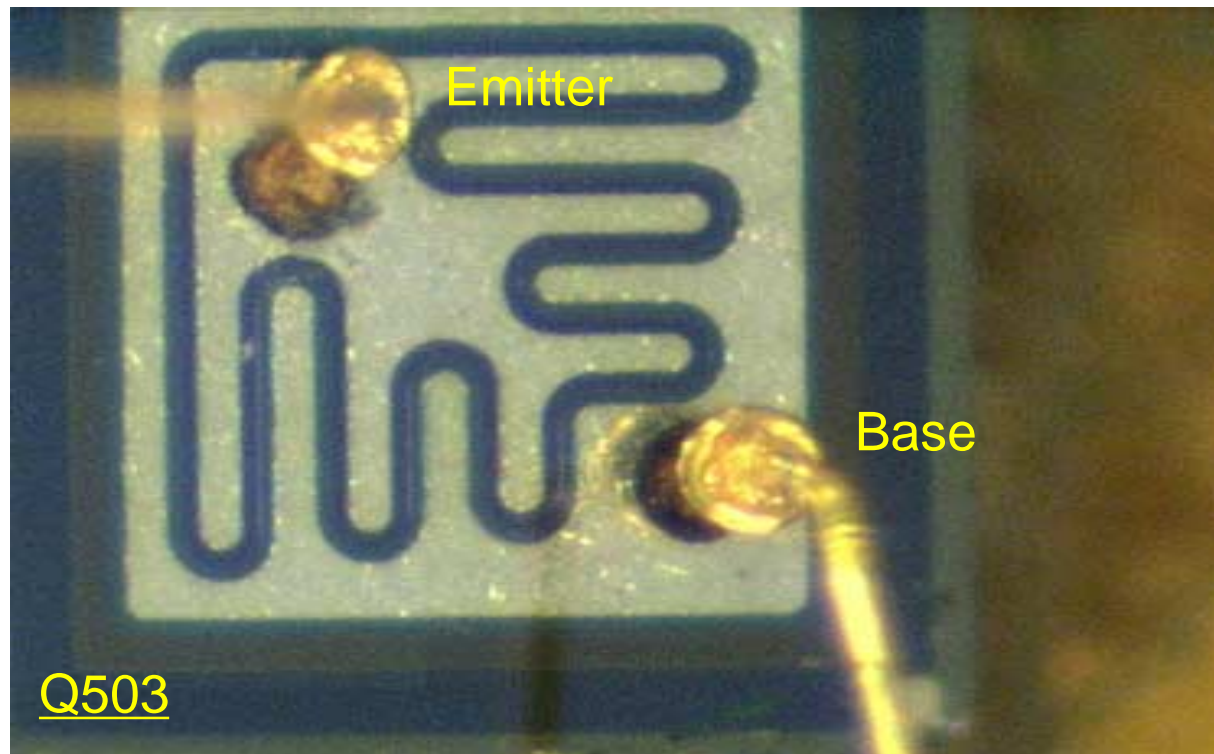
Figure 2

**Closer Examination Shows Bond Wires Are Actually Detached**

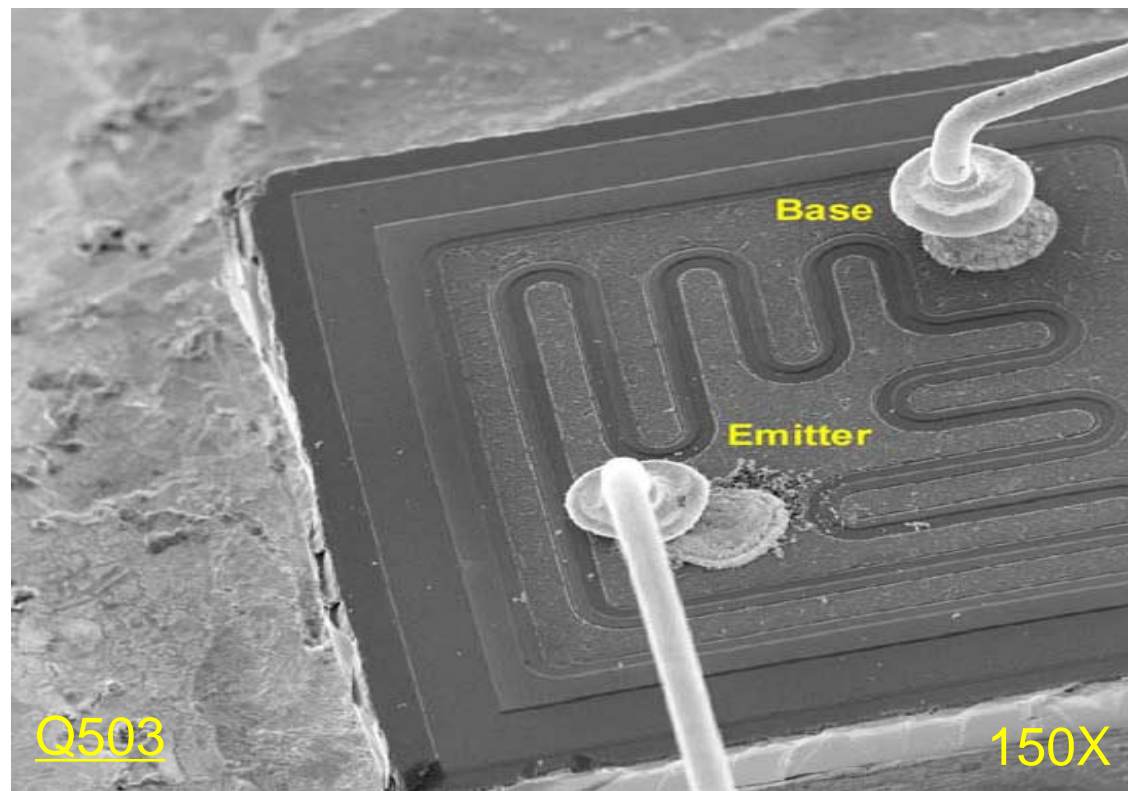
Figure 3

### SEM of Detached Base and Emitter Bond Wires

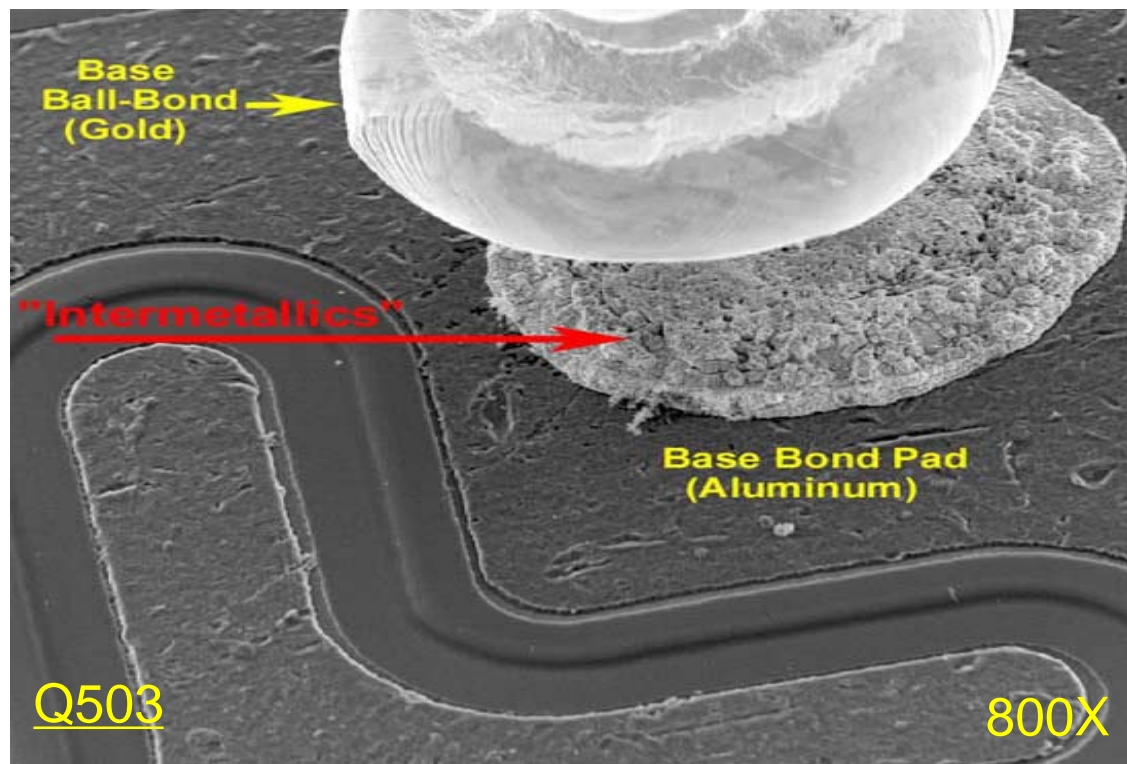
Figure 4

### SEM Showing Intermetallics In Bond Region

- The 2N3019 transistor design employs gold bond wires attached (via thermal compression) to an aluminum die substrate forming a strong intermetallic bond
- Diffusion of aluminum into gold results in the formation of an intermetallic compound which tends to exhibit a purple coloration, at and around the periphery of the aluminum-to-gold interface
  - The presence of this material is not, in and of itself, an indication of an inferior mechanical connection
  - However, if the intermetallic compound progresses to develop Kirkendall voids, the integrity of the mechanical connection may be undermined
    - The potential for void formation is accelerated in the presence of certain contaminants (i.e., chlorine, bromine, fluorine, etc.)

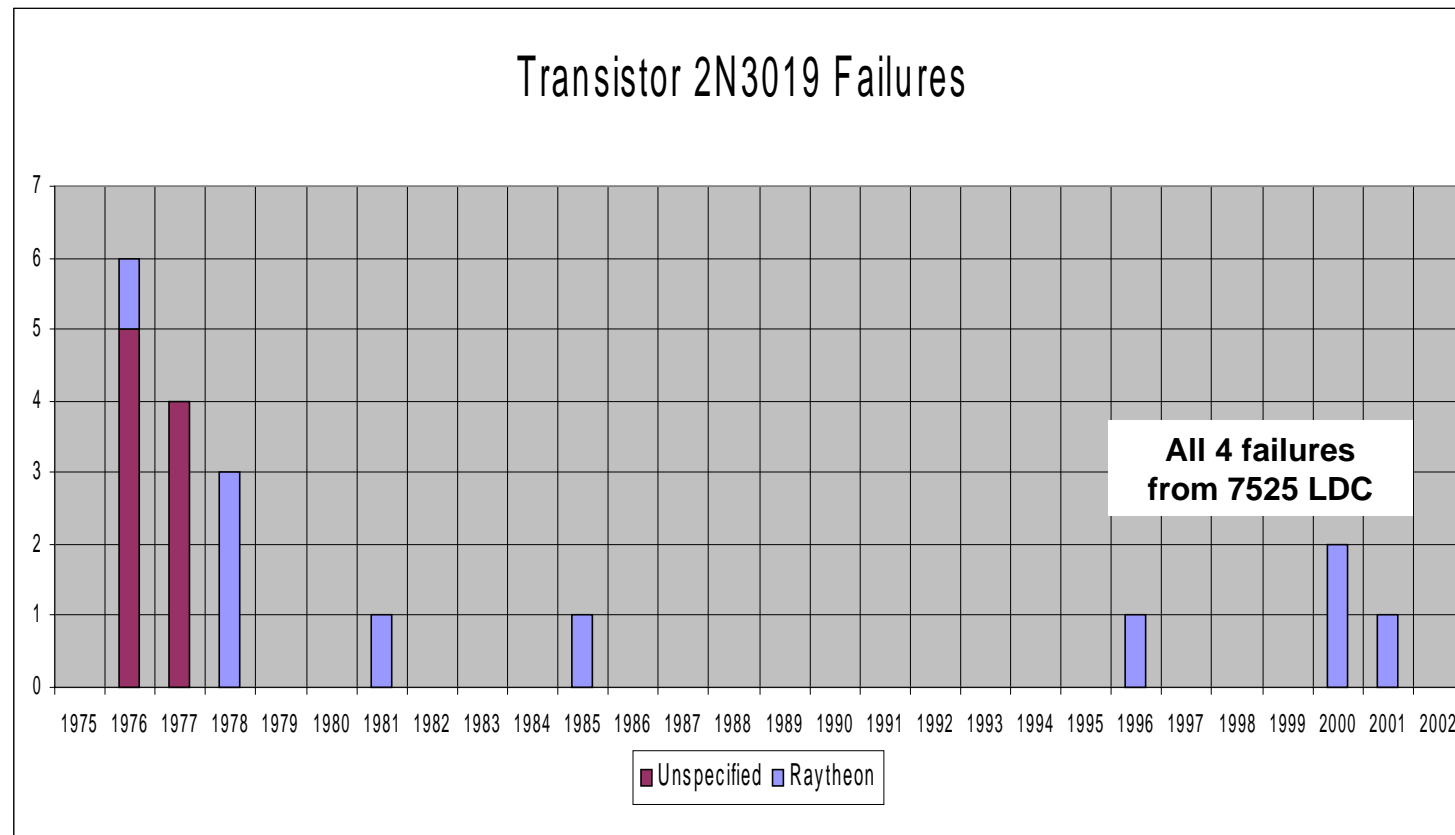
Figure 5

- Conducted PRACA history search to identify all 2N3019 transistor failures (refer to Figure 5)
  - Identified 16 CARs documenting 19 transistor failures (various manufacturers)
  - Due to incomplete documentation, only 8 CARs confirmed to involve Raytheon transistors
  - No records contained information regarding destructive failure analysis
    - One record indicated that transistor was de-lidded and photographed, but in most cases transistors were simply R&R'd
- Four recent failures led us to investigate LDC 7525 as a potential lot problem
  - Aerospace Corporation failure database
  - GIDEPs
  - Additional failure analysis at NSLD
  - Destructive testing of randomly selected parts at Hi-Rel
