**Investigation Report of the STS-87
SPARTAN Close Call**

Date of Close Call: November 21, 1997

Johnson Space Center

March 2, 1998

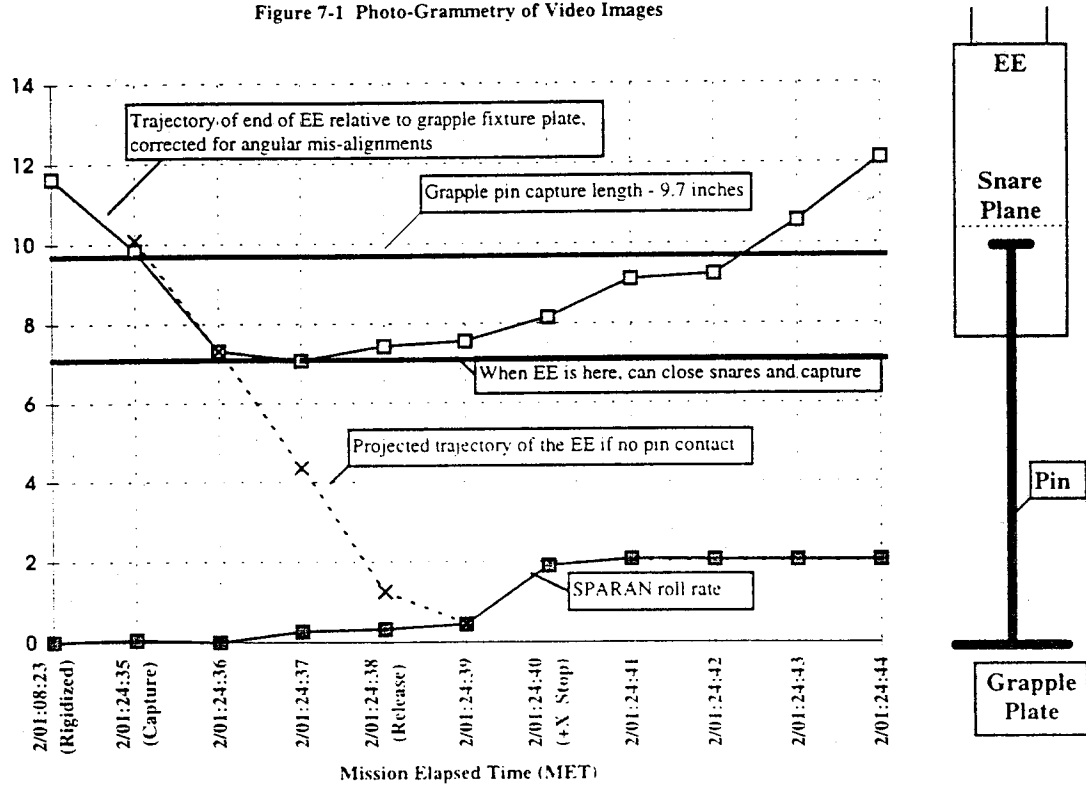
Figure 7-1 Photo-Grammetry of Video Images

the capture envelope. The SPARTAN rate data retrieved from its tape recorder indicate that the tip-off occurred at about the time of the Release command. The photo-grammetric analysis suggests that the tip of the pin was at the snare wire plane at about the same time. Further, the photo-grammetry indicates that the EE approached no closer to the grapple plate than at the time of tip-off, even though the RMS was continuing to be commanded toward the SPARTAN for several additional seconds. Hence, the board concludes that the snare wires pushed the SPARTAN away as well as inducing rotation. (Reference Volume II, Appendix I.)

At the time the capture command was issued, the EE was in motion toward the SPARTAN at about 0.2 ft/sec and this continued for about 5 seconds thereafter (about 12 inches). The resultant trajectory of the RMS is described here in the orbiter X, Y, Z coordinate system, though the SPARTAN was not aligned with that coordinate system. Thus, in the X direction there was about 11 inches of movement aft, in the Y direction there was motion to the left (as viewed from the EE camera) about 5 inches and then back to the right about 5 inches. In the Z direction, there was movement up about 6 inches. There were no RHC inputs during this time.
