# THE NEAR DISCOVERY MISSION: LESSONS LEARNED

R. H. Maurer and A. G. Santo  
The Johns Hopkins University Applied Physics Laboratory  
Johns Hopkins Road  
Laurel, MD 20723-6099 USA

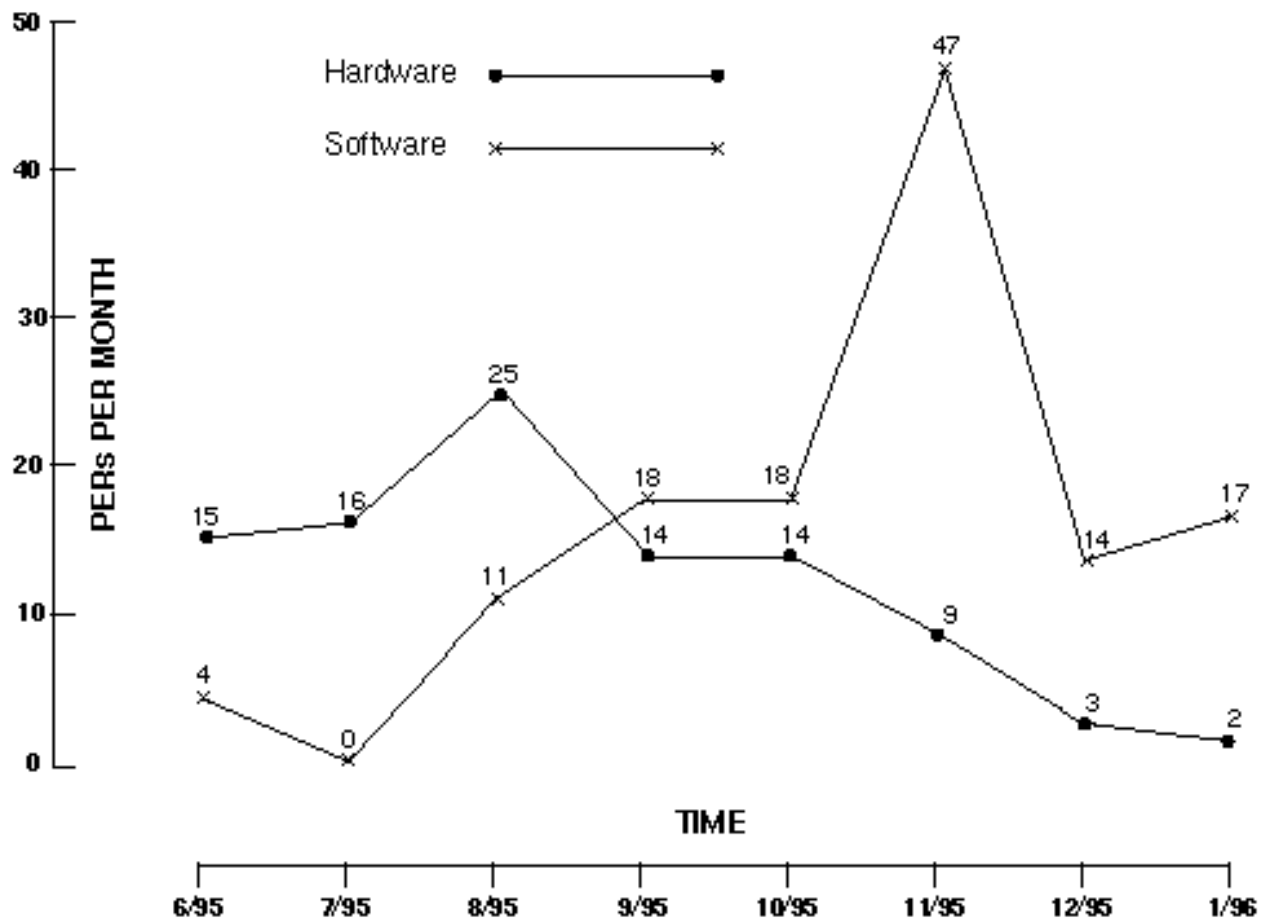
Figure 2. NEAR PFR Matrix

The analysis of means on the two factor interactions showed that greater numbers of anomalies were produced by the appropriate combinations of:

- (1) the design of the Guidance and Control subsystem software after going to the field due to the complexity of the G&C subsystem for an interplanetary mission and the fast paced NEAR schedule which required writing and debugging flight computer software in the field;
- (2) the design of the science instrument hardware before going to the field reflecting the less mature design of the instruments, particularly the x-ray/gamma ray spectrometer, and the design of doors and door opening mechanisms;
- (3) the basic spacecraft design before going to the field due to wiring, interface and connector problems (hardware) and the correct implementation of autonomy rules (software);
- (4) the ground support (test) equipment software design.

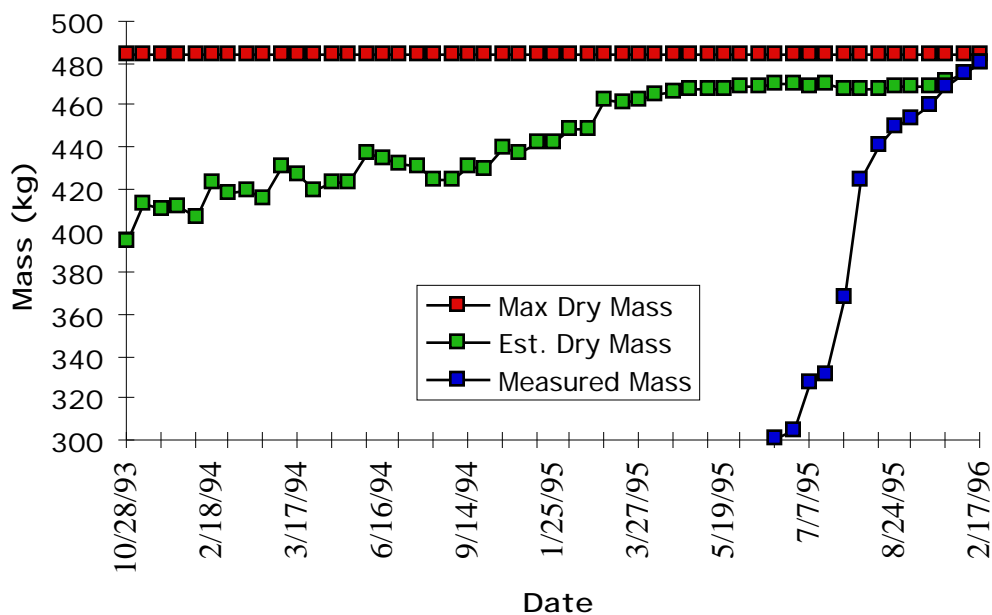
Figure 3. Dry Mass History

Throughout the entire program mass was the main spacecraft driver. Figure 3 shows the dry

mass history. The program started with 17% margin and launched 5 kg extra fuel, (1% margin). It can be seen that the dry mass had a steady upward trend of about 1% per month during the design and fabrication phase (11/93 till 3/95), was relatively flat during the integration and test phase (4/95 till 2/96), and had a small jump near the end of the program. The increase at the end was due to the thermal blankets and the spin balance mass, both of which were carried as estimates until they were installed at the launch site.
