NASA TN D-7609

APOLLO EXPERIENCE REPORT -
COMMAND AND SERVICE MODULE
ELECTRICAL POWER DISTRIBUTION SUBSYSTEM

by Robert E. Munford and Bob Hendrix

APOLLO EXPERIENCE REPORT
COMMAND AND SERVICE MODULE
ELECTRICAL POWER DISTRIBUTION SUBSYSTEM

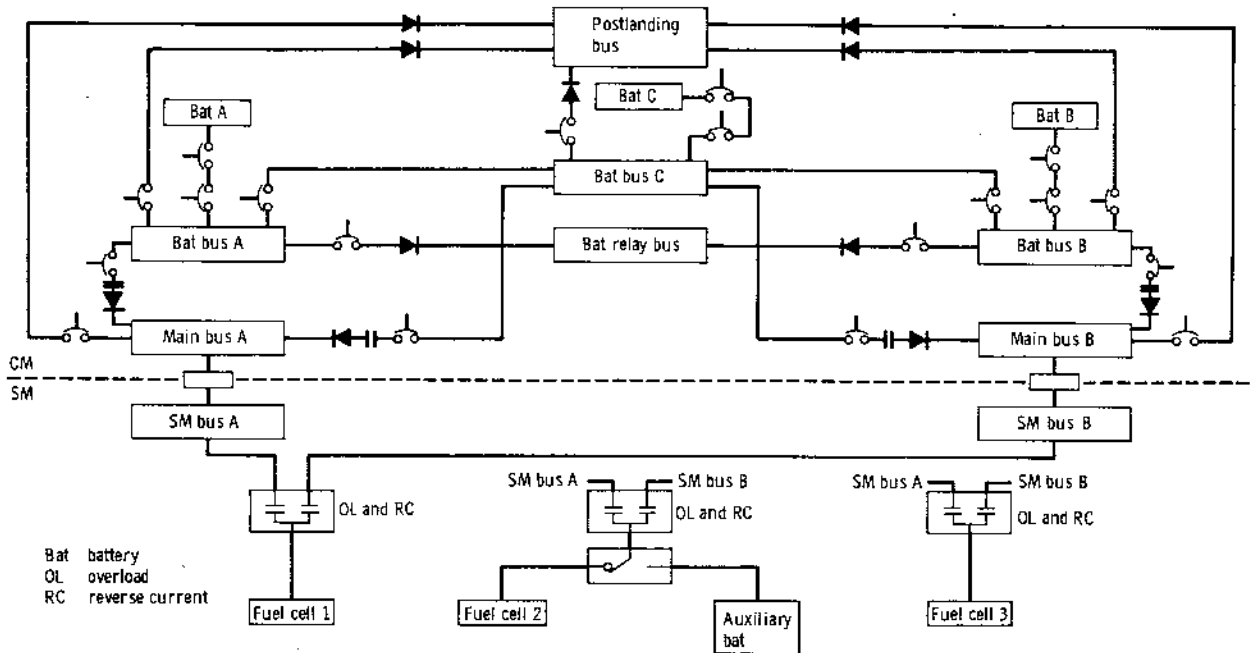
Figure 1. - Structure of direct-current buses.

The direct-current system (fig. 1) accepted power from three fuel cells and three entry batteries and distributed this power to two main direct-current buses. Loads on the buses were divided into the following three categories according to criticality and power source.

1. Nonredundant essential loads were fed from both buses through isolation diodes.
2. Redundant essential loads were arranged so that loads were fed from different buses.

3. Nonredundant nonessential loads were connected to the buses, as required, to equalize the loading on each bus.

The basic design of the direct-current distribution system (fig. 1) consisted of two buses (main bus A/SM bus A and main bus B/SM bus B) that were isolated from each other and energized by three fuel cells or three entry batteries. Redundant loads were connected to separate buses. Nonredundant critical loads were fed from both buses through diodes or double-throw switches to provide circuit isolation. Nonredundant noncritical loads were tied to either bus, as required, to equalize bus loading.

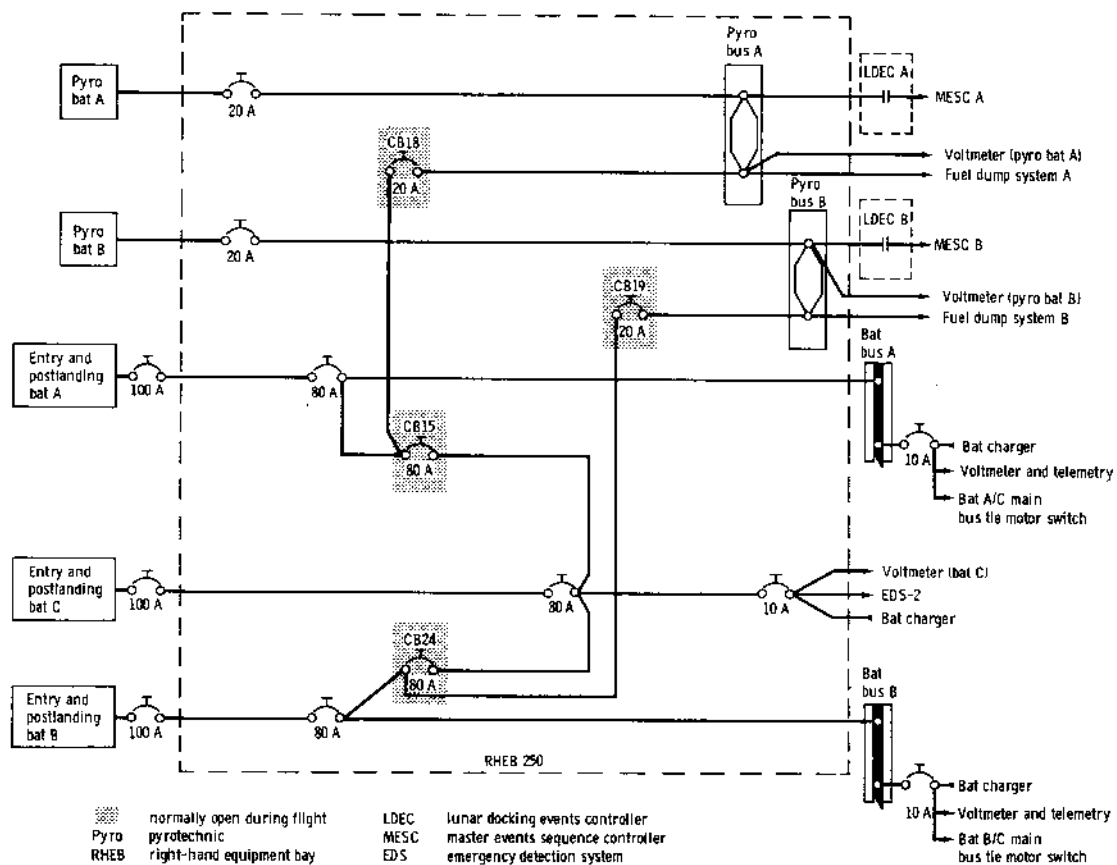
Figure 2. - Battery circuits.

As time passed, the need for added flexibility of power sources became apparent, resulting in the addition of circuit breaker (CB) 15 and CB24 (fig. 2) to make it possible

to put any battery on any bus in the power system. In addition, CB18 and CB19 were added to permit activation of a pyrotechnic bus by an entry battery if a need occurred. Although many other minor changes were made in both design and procedures, the system and system components remained basically the same as those flown in 1966 on spacecraft 009, the first Block I vehicle launched from the NASA John F. Kennedy Space Center. The more significant of these changes are reviewed in the following discussion.

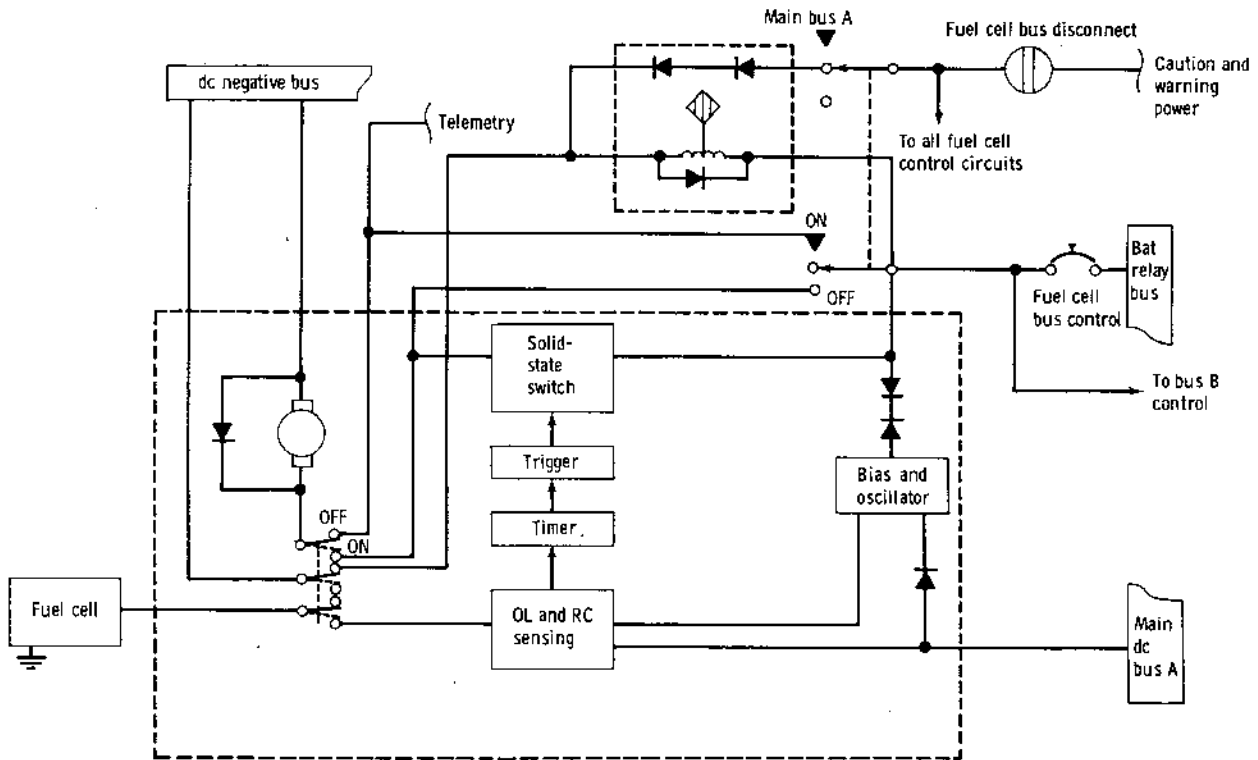
Figure 3. - Fuel cell control circuit.

The large circuit breakers on the output of the entry batteries were directly attached to the battery-mounting hardware to protect the wires leading to the first control panel. Overload and reverse-current sensors for each fuel cell (fig. 3) served a similar purpose in the SM.

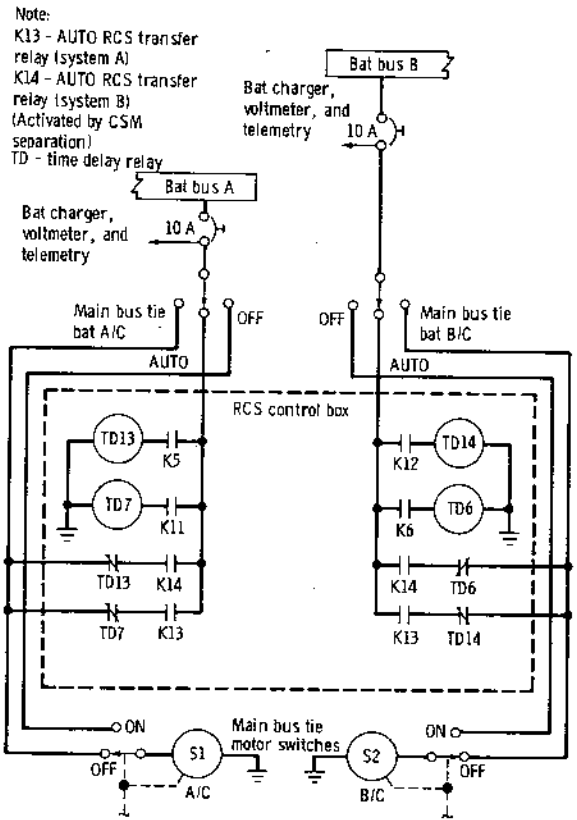
Figure 4. - Entry battery/main bus tie control.

A timing circuit (fig. 4) in the reaction control system (RCS) provided automatic switching to connect the entry batteries to the main buses in the event of a pad abort. This feature allowed battery power to be conserved by operating the vehicle from ground power until just before lift-off. If an abort was necessary, crew action was not required to provide power to the CM after separation from the SM.

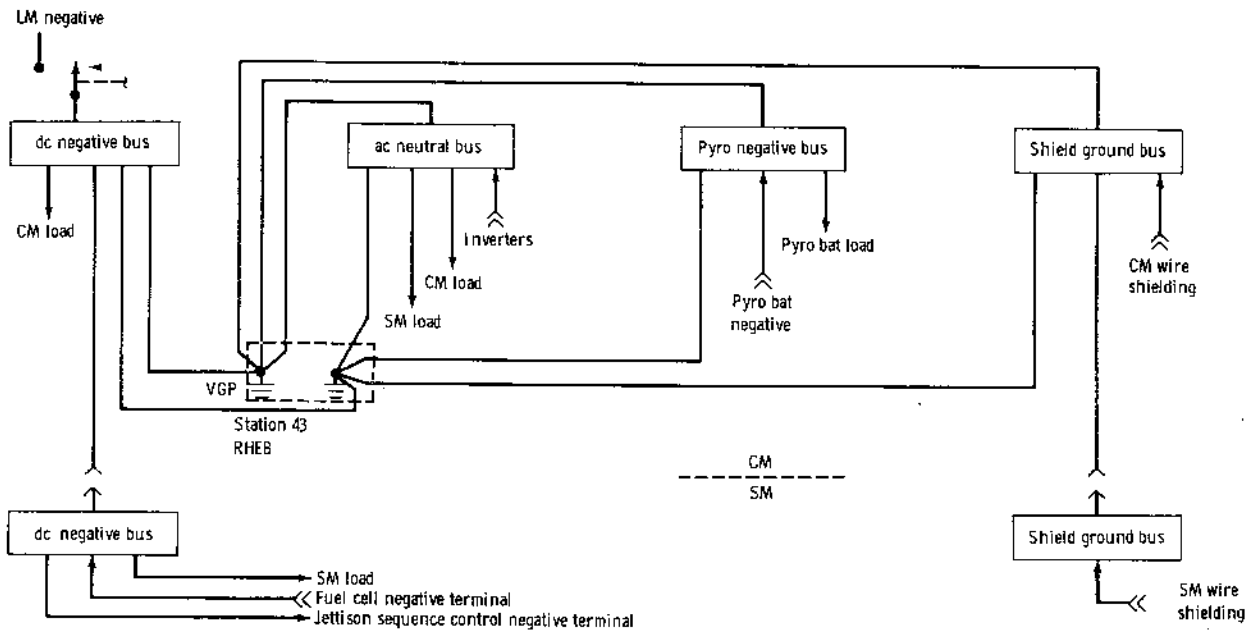
Figure 5. - Vehicle ground point.

To minimize electromagnetic interference (EMI) from structural current, a single-point ground was used for the direct-current return, alternating-current neutral, pyrotechnic-initiating circuit returns, and shield grounds. This design is shown in figure 5 with all grounds returning to the vehicle ground point (VGP). When the CM was docked with the lunar module (LM), all current flowing from the CSM to the LM was returned to the VGP through the CM/LM umbilical, thereby maintaining the single-point ground configuration. Individual buses were provided to separate the power and signal grounds from the LM and CM until the grounds were tied to the VGP.

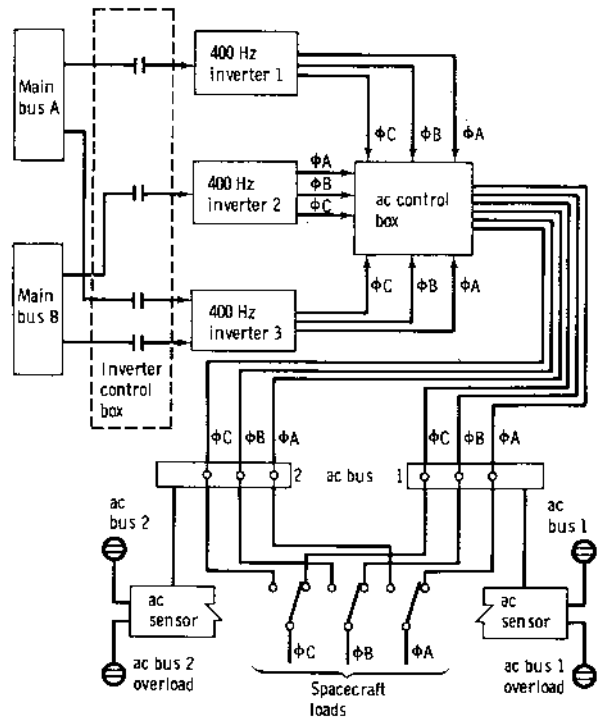
Figure 6. - Alternating-current power distribution.

Three-phase 400-hertz alternating current was delivered through two four-wire buses that could be energized by one or two of the three static inverters (fig. 6). Each inverter had sufficient capacity to supply all alternating-current power required by the vehicle. This could be accomplished by paralleling both alternating-current buses to a single inverter, or each bus could be energized by individual inverters; however, the inverters could not be paralleled without causing damage to the inverters.

Circuits were provided in the alternating-current power control box that prevented parallel operation of the inverter outputs if improper procedures were followed. However, this switching system had defects involving a race between motor switches that could cause the loss of all alternating current to the spacecraft. This problem was overcome by rewiring the control switches on a priority system so that no switch race was possible.

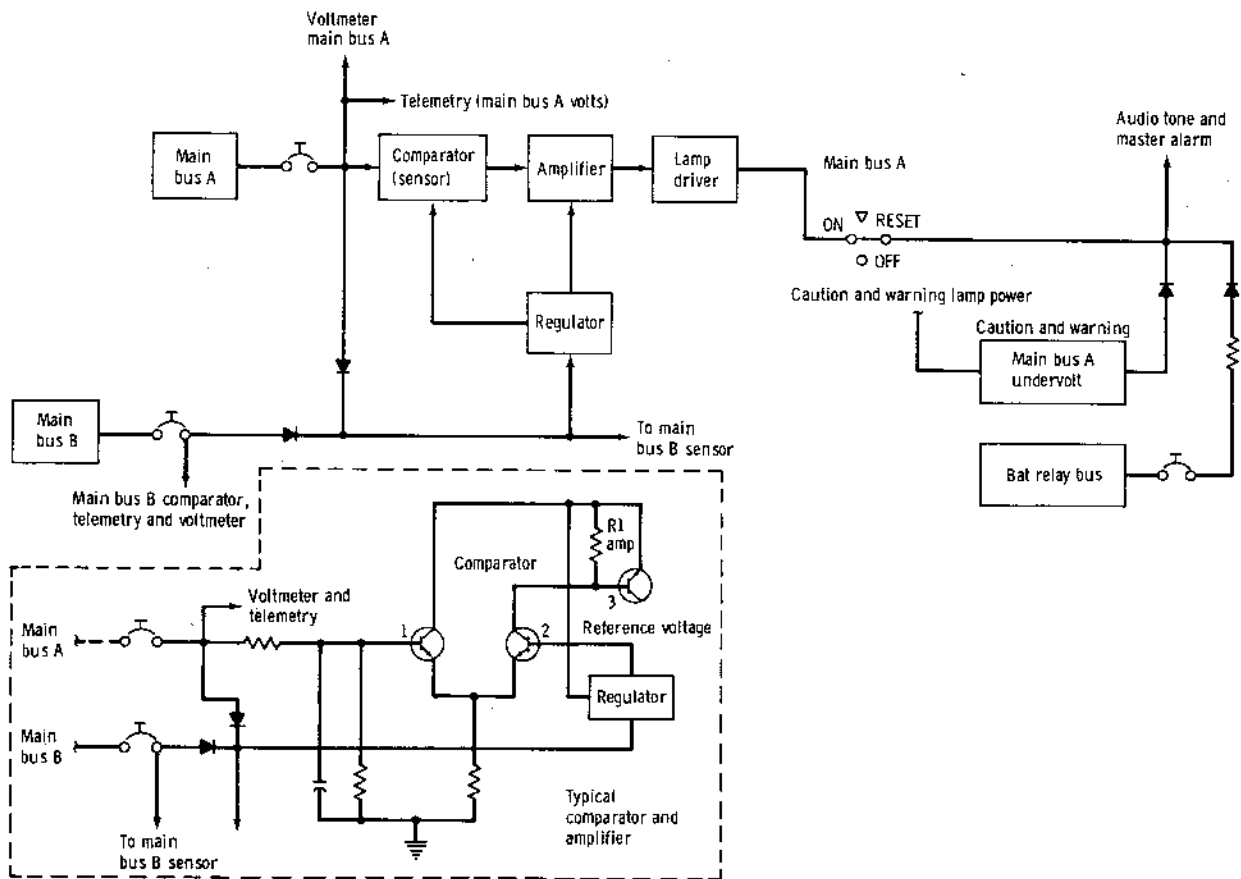
Figure 7. - Direct-current undervoltage-sensing circuit.

Sensors monitored the main direct-current buses for low voltage (fig. 7) and signaled the caution and warning (C&W) system if the voltage level fell below 26.25 volts. Alternating-current buses were monitored by sensors (fig. 8) for low voltage, overload, and overvoltage. If either the load or voltage went out of limits, a C&W signal was initiated; however, of the three anomalous conditions, only an overvoltage condition required corrective action to be taken faster than a crewmember could react to the situation. Therefore, an overvoltage condition resulted in automatic disconnection of the faulty inverter.

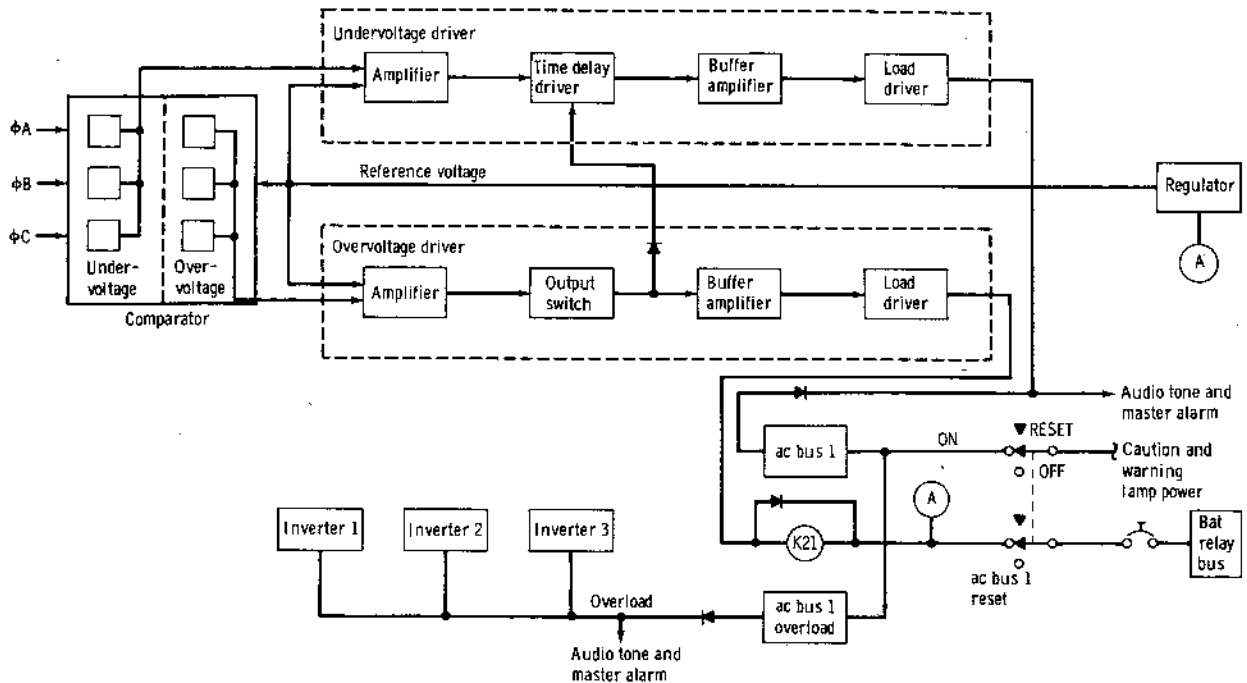
Figure 8. - Alternating-current sensing circuit.

Originally, the alternating-current sensing circuitry was designed to automatically disconnect an overloaded bus; however, because silicone-controlled rectifiers (SCR) in the inverter overload sensor circuit proved to be overly sensitive to current surges, several unnecessary losses of alternating-current power occurred. As a result, the disconnect feature of the sensor was disconnected, but the C&W alarm was retained. Mission success was not impacted because a crewman was always present in the CM to take the action required for an overload-bus condition.

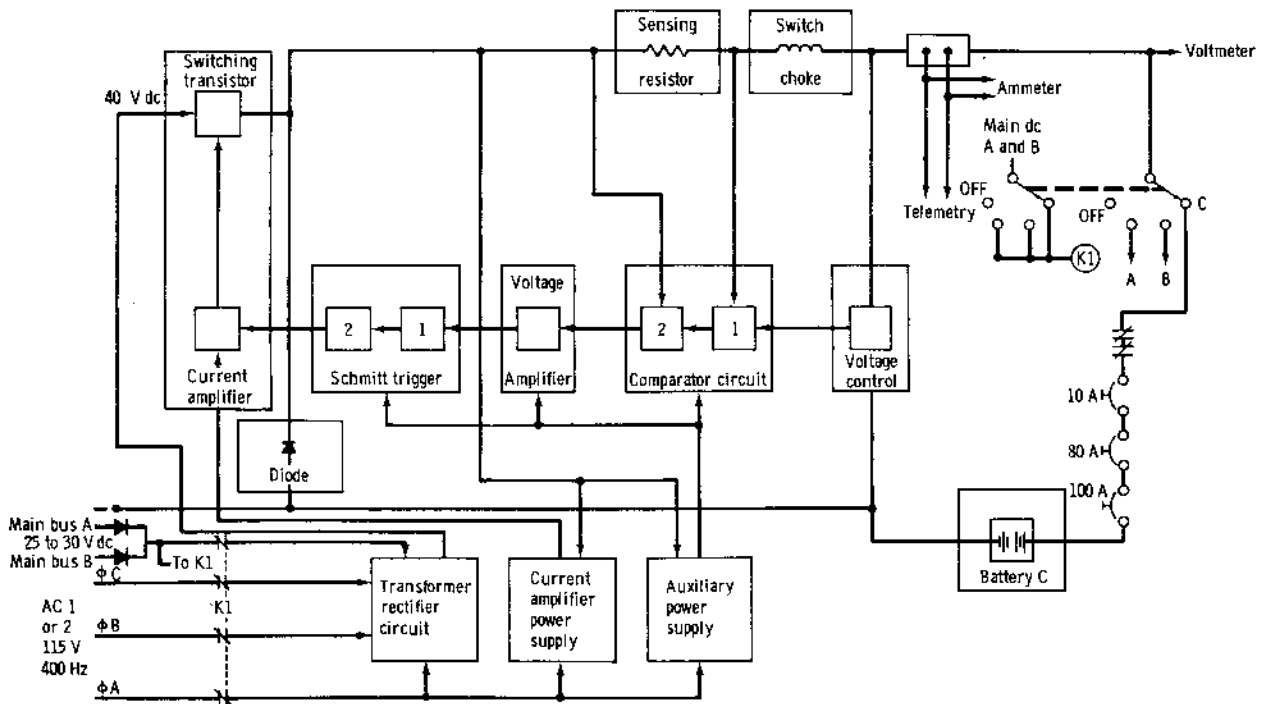
Figure 9. - Functional diagram of battery charger.

The battery charger (fig. 9) also was modified after fabrication because the output was originally calibrated for a particular current and wire routing. However, subsequent reconfiguration of the wiring and the addition of circuit breakers resulted in a buildup of tolerances which, when combined, caused the charger output to be inadequate. The unit had to be partly depotted to gain access to the potentiometer that controlled the output voltage level. Setting the potentiometer control at the proper level solved the problem.

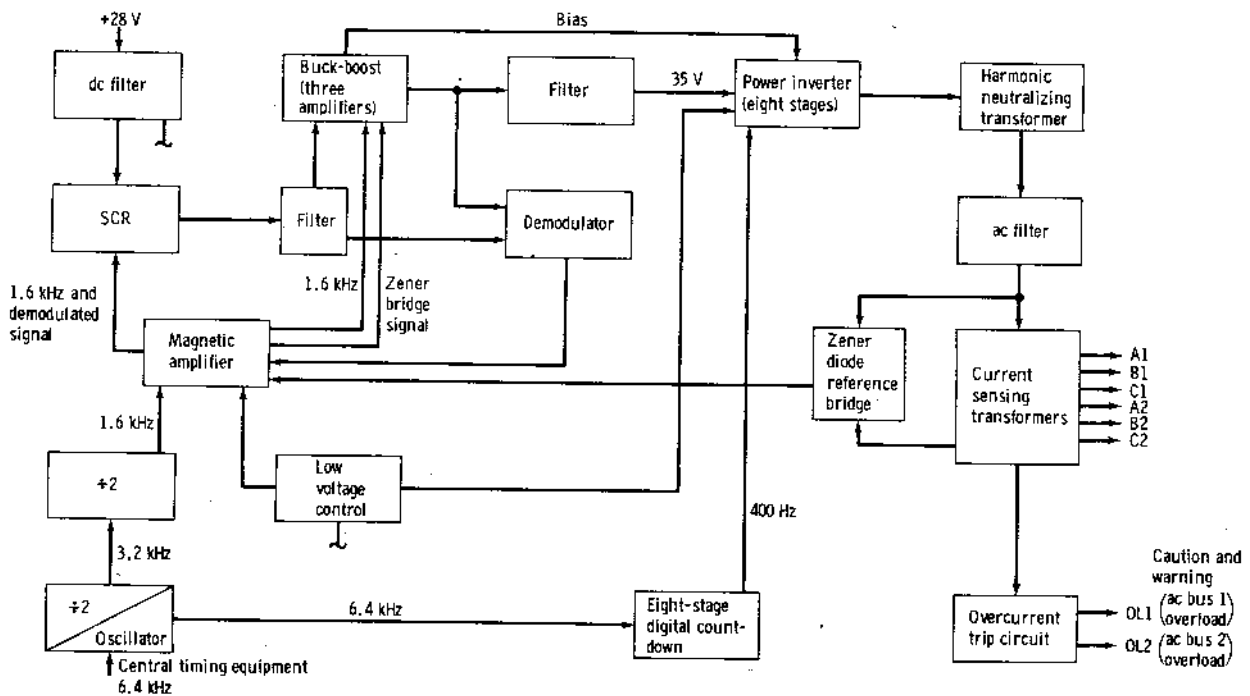
Figure 10. - Inverter block diagram.

The original inverters, designated as the -0001 model, were modified several times after the flight of spacecraft 009 in early 1966. Each time a major modification was made in the design of the inverter, the model was designated by a new dash number to control usage. One such modification, which resulted in the -0004 model, was made because alternating-current modulation adversely affected the performance of the S-band transponder.

The inverter housing was redesigned for Block II spacecraft inverters to facilitate easy removal for repair purposes. At the same time, output connectors were installed in place of the terminals that were used on earlier models. Another change to the inverter was made after the Apollo 204 fire. The inverter housing was sealed to prevent propagation of fire if any component within the inverter ignited. This inverter became the -0008 model.

The -0008 model was installed on the first series of Block II spacecraft and performed satisfactorily; however, the manufacturer of the power-switching transistors used in the inverters experienced difficulties in meeting delivery schedules. Consequently, a second source was selected to supply transistors with similar characteristics. The transistors from the second source had a slightly faster switching speed than the original ones; therefore, minor circuit modifications had to be incorporated, resulting in the -0010 inverter configuration. The -0010 model was first flown on the Apollo 10 mission and performance was normal. Although the design was not altered after this configuration, thermal-acceptance testing of all black boxes became mandatory later in the Apollo Program. As a result, the -0008 and -0010 units became, after testing, the -0012 and -0014 units, respectively.

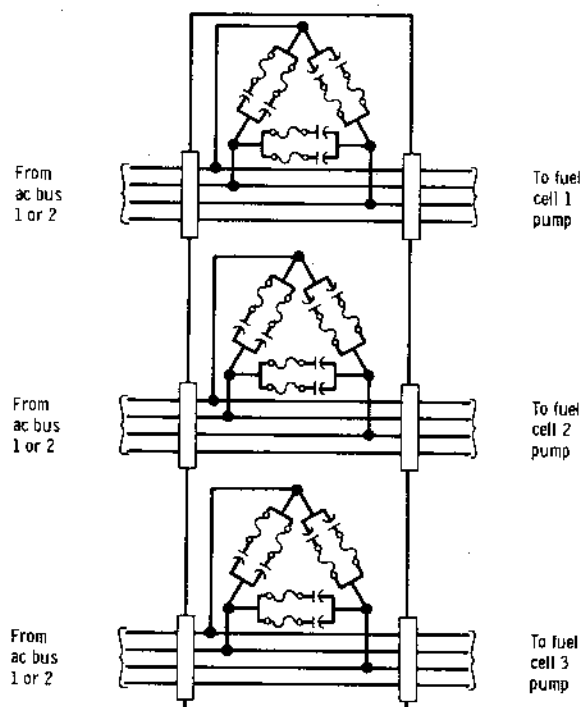
Figure 11. - Power factor correction box.

Most of the alternating current generated was used to power fuel cell pump motors; consequently, the load was highly inductive. To compensate for the undesirable power factor resulting from this load, a capacitor bank was added to the motor circuits (fig. 11). These capacitors, together with protective fuses, were installed in the power factor correction box, which was originally located in the CM. The box was not changed for the Block II configuration, but the fuel cell pump motors were redesigned. Because the new pump motors had a much better power factor than the old motors, it was found that, when the correction unit was used, the power factor was overcompensated and effectively nullified all gains from the correction unit. To rectify this problem without impacting schedules, some of the capacitance was removed by altering the panel wiring rather than by redesigning the box. This modification was made on early Block II vehicles.

At a subsequent design review, it was determined that the correction unit contained a single failure point because current from both buses was routed through a single connector. At approximately the same time, an effort was underway to remove weight from the CM to lessen the load on the parachutes during entry. Because the power factor correction box functioned only when the fuel cell pump motors were in use, there was no requirement for the unit after the SM was jettisoned. Consequently, after the box was redesigned to eliminate the single failure point and to optimize the power factor, it was installed in the SM.

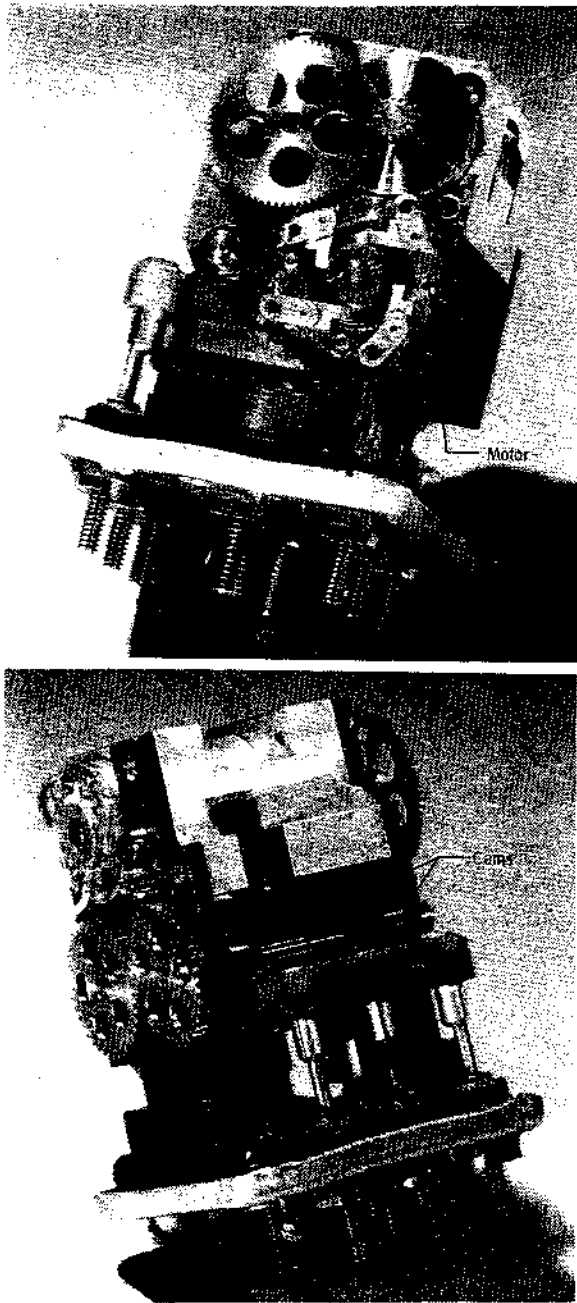
Figure 12. - Motor switch assembly.

The most complex piece of mechanical gear in the electrical power system was the motor-driven switch (fig. 12). Thirty-eight of these switches, in various configurations, were installed in each Block II

sive heating and the armature windings had opened. Additional investigation and disassembly of the motor showed that the commutator bars were separated from the rotor and presented evidence of extreme heat in the area of the brush/commutator interface. Furthermore, the buildup of residue on the commutator was far greater than normal.

During the first flight of a Block II vehicle, a problem appeared in a motor switch while it was removing three-phase power from fan motors. It was determined that the switch, which normally was back-filled with an inert gas and sealed with an environmental seal (metal to epoxy), had leaked to an altitude favorable to arcing. As a result, when the switch interrupted the highly inductive load, arcing occurred in the switch and sufficient EMI was created to trip the alternating-current sensor. The problem was overcome procedurally in real time; nevertheless, motor switches that are not hermetically sealed (metal to metal or glass to metal only) are no longer considered suitable for alternating-current circuits in vacuum applications.

A more serious problem became apparent after the Apollo 14 mission. As a result of an investigation, a new failure mode of the motor switch was discovered. A switch in the direct-current power control box failed in midtravel. When the switch was opened for inspection, it was found that the motor armature had undergone exces-

During a thorough investigation, many switches were tested and then disassembled to facilitate a microscopic examination of the mechanism. No abnormal conditions were found in the gear train or other mechanical parts of the switch, and, in all anomalies of this type, it was determined that the motor was at fault. Small silicone grommets, used as seals in the motor housing, were not cured under uniform conditions; those not cured completely tended to revert to their precured condition. This reversion process was present at all temperatures; however, heat aggravated the condition. As the reversion progressed, the catalyst that was used for curing the silicone was released and migrated to the motor commutator where it combined with bearing oil and brush residue to form a high-resistance deposit between the brushes and commutator. This deposit resulted in excessive heat being generated at the interface, a low armature current, and, consequently, low motor torque. Loss of torque caused the motor to stall until the heat generated within the motor was sufficient to cause a wire in the armature to open.

Motor-current traces, which depict the time required for the switch to transfer, and the amplitude of the current were taken before each operable switch was disassembled. These traces were compared with similar traces taken by the vendor during the fabrication of the switches. As a result of numerous trace evaluations, the transfer time, which proved to be a reliable indicator of the condition of a motor commutator, was used to identify switches with potential motor problems. The evaluation also established a maximum time in which a switch with a clean commutator should transfer; consequently, current traces were made for all switches in several phases of the checkout to determine the transfer time of each. Any switch with excessive transfer time was replaced.

Another anomaly was discovered during the evaluation of current traces. Two switches did not begin transferring current until 50 to 100 milliseconds after power was applied. This condition was caused by a sticking brake on the motor. The brakes stuck because of cold flow of the brake lining after long periods of inactivity. After the switches were operated once in the vehicle checkout, they no longer had a tendency to stick, and that particular failure mode was of no further concern.
