MPR-SAT-63-1  
January 8, 1963

SATURN SA-3 FLIGHT EVALUATION

VOLUME I

By Saturn Flight Evaluation Working Group

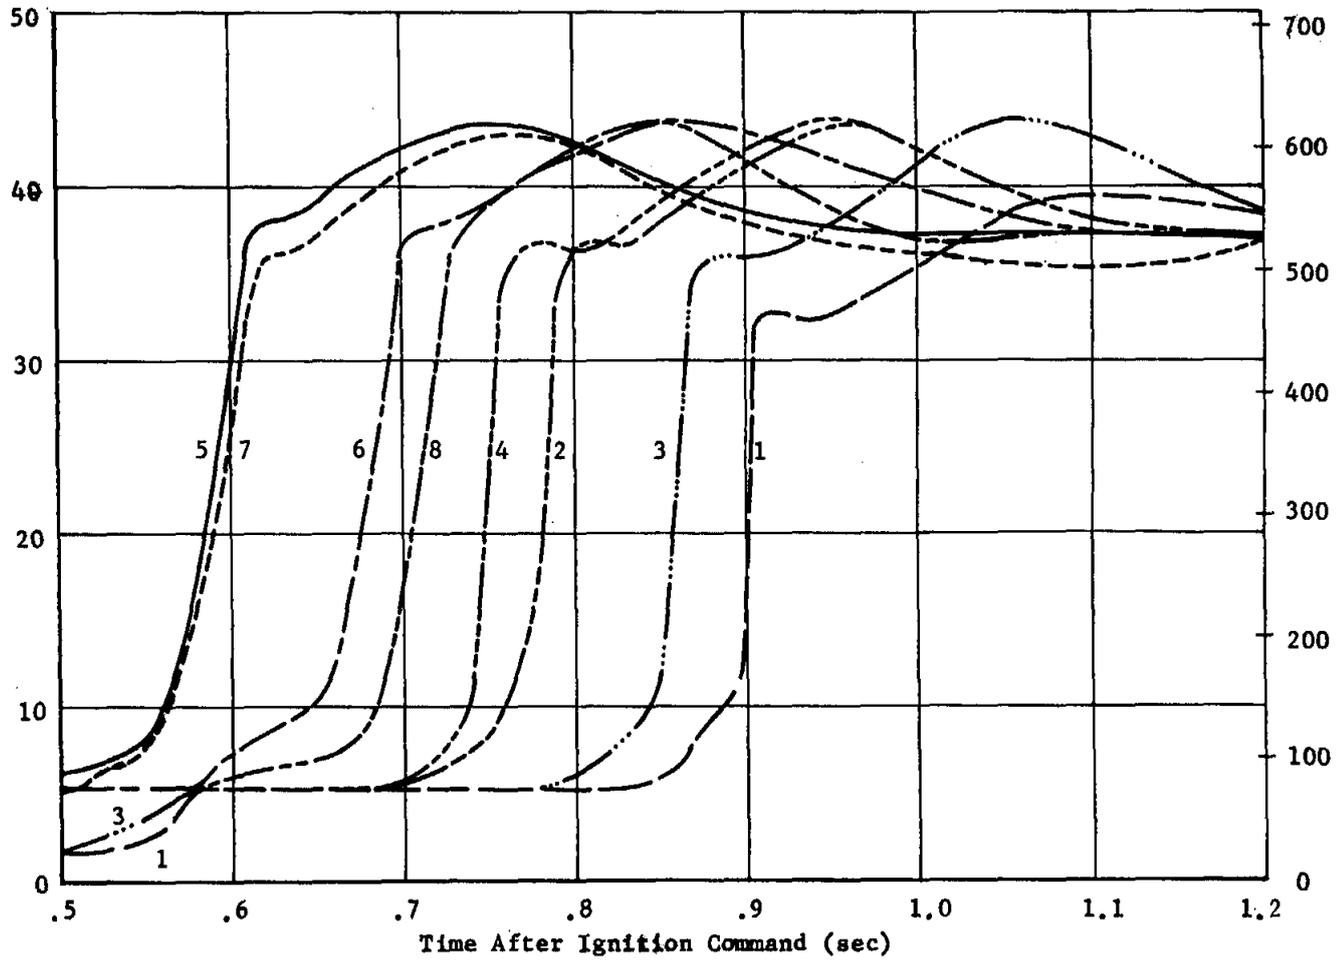
FIGURE 5-1 CHAMBER PRESSURE BUILD-UP

The engine starting sequence was within expected values of predicted. Figure 5-1 shows the chamber pressure build-up of all engines. The starting pairs by position number were 5, 7; 6, 8; 2, 4; and 1, 3 with a programmed 100 ms delay between pairs. The maximum deviation in chamber pressure build-up of approximately 40 ms occurred between engines 1 and 3. This deviation is within expected engine-to-engine repeatability limits.

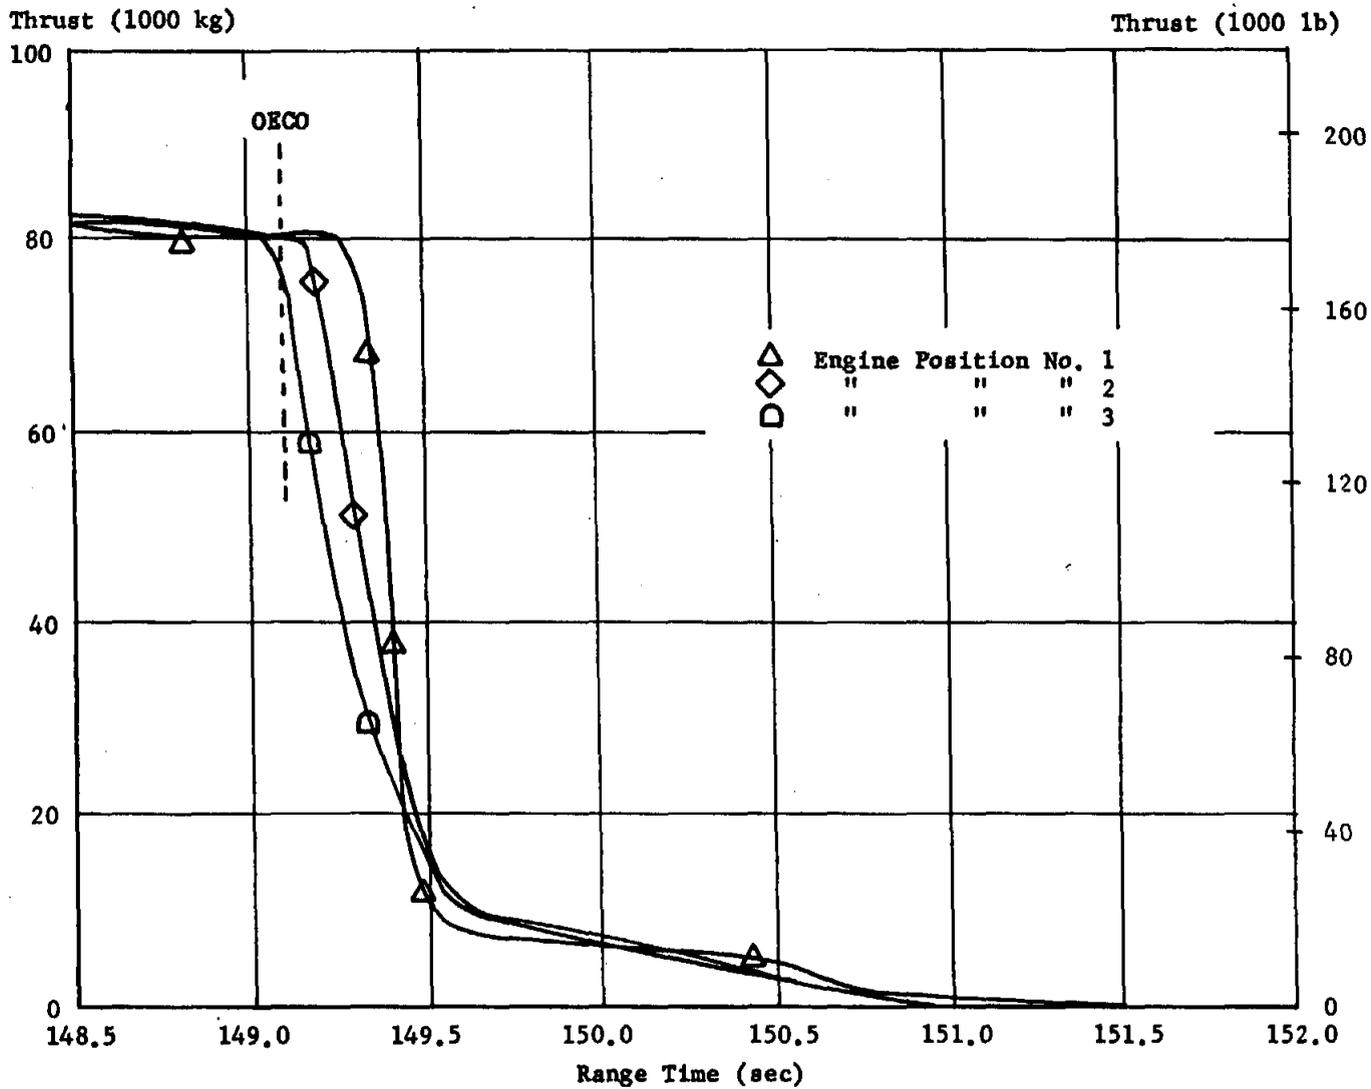
FIGURE 5-2 OUTBOARD ENGINE THRUST DECAY

Inboard engine shutdown was normal on all four engines. The outboard engine cutoff characteristic was modified slightly by the LOX depletion cutoff (see Figure 5-2).

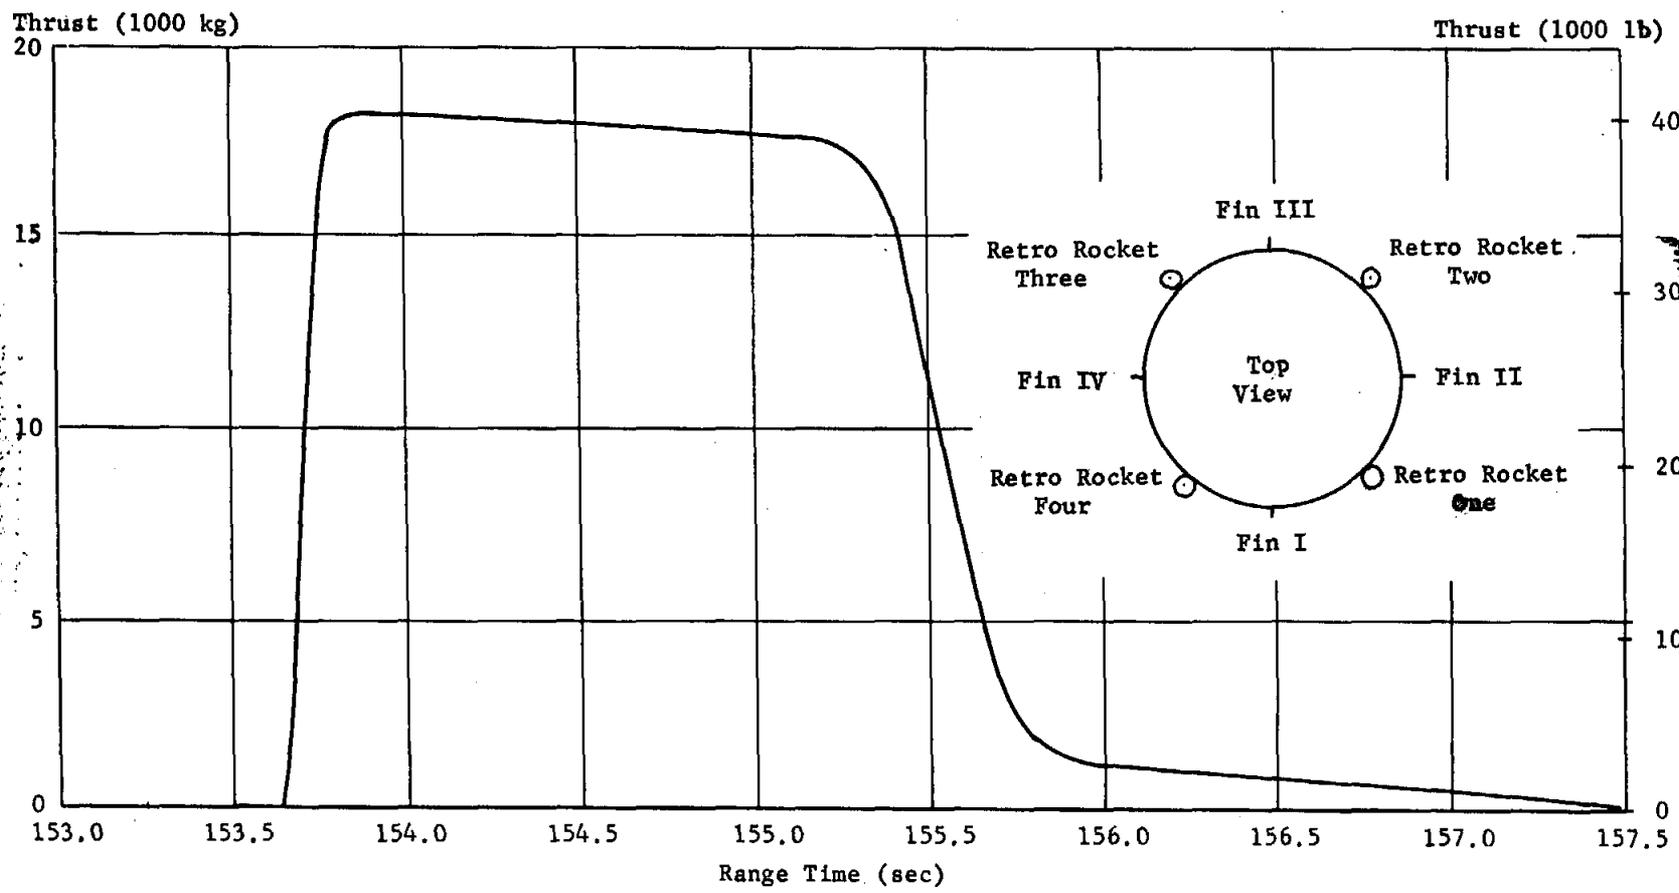
FIGURE 5-5 TYPICAL RETRO ROCKET CHAMBER THRUST

A typical retro rocket thrust curve is shown in Figure 5-5. Telemetered retro rocket chamber pressure data indicated satisfactory retro rocket performance and approximately equal performance levels for the four retro rockets. The performance of the retro rockets was within expected limits of the predicted, with total impulse as calculated from measured chamber pressures being about 1.7% higher than predicted. The performance as calculated from chamber pressures is substantiated by flight mechanical measurements (see Section 4.4). Measured and calculated retro rocket performance parameters are listed in Table 5-III along with some predicted values.

During retro rocket operation, a vehicle roll (clockwise viewed from the rear) of approximately 4.3 deg/s occurred and is attributed to a retro rocket misalignment of approximately 0.3 deg for each rocket.

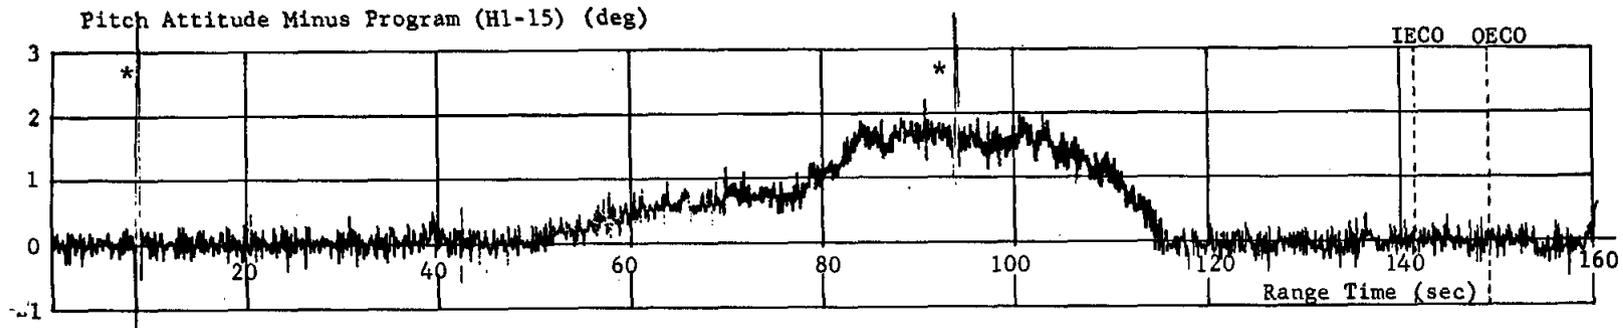
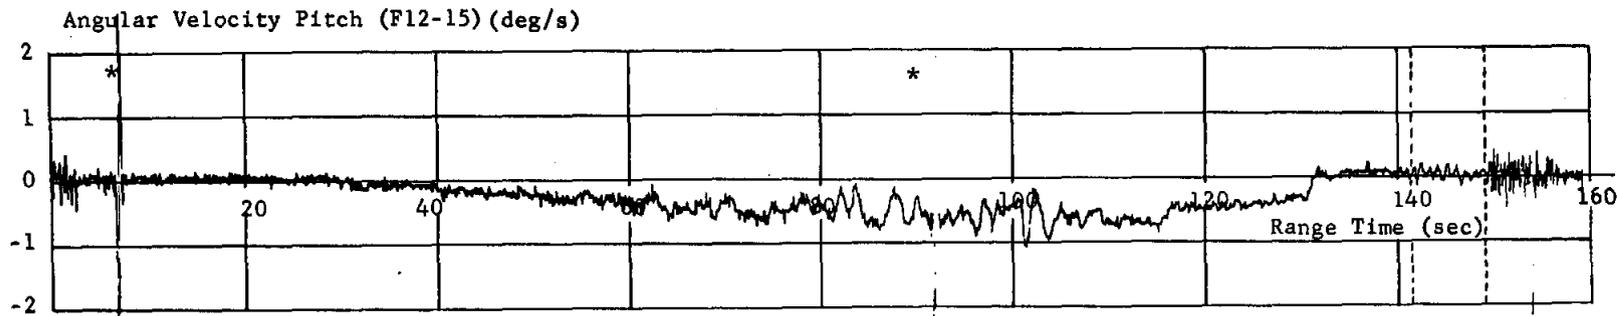
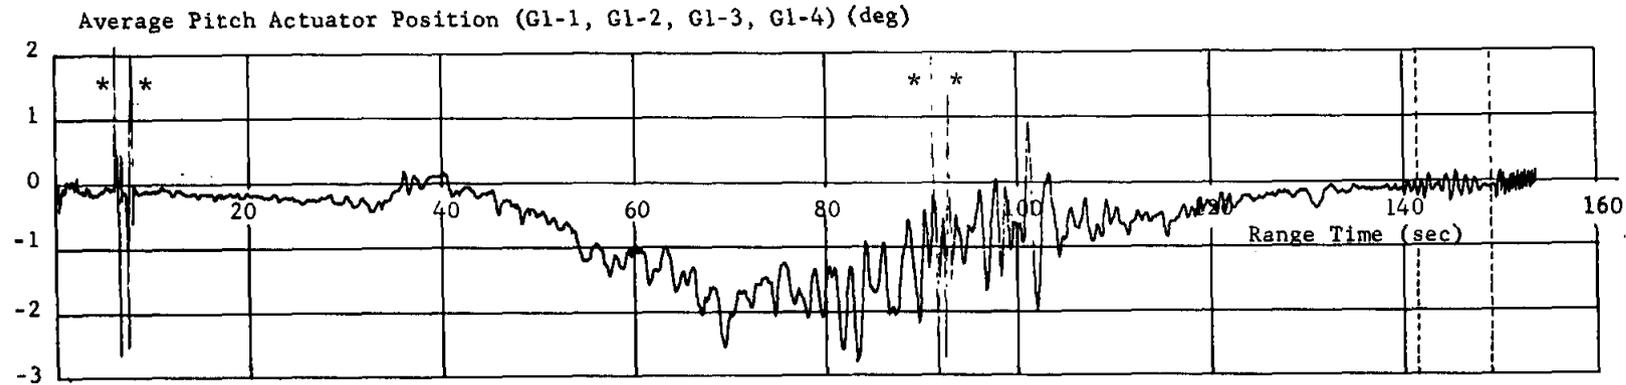
FIGURE 7-1 PITCH ATTITUDE, ANGULAR VELOCITY AND AVERAGE ACTUATOR POSITION

The maximum actuator deflection of -2.8 degrees occurred at 83.3 sec (Figure 7-1) as a result of a wind gradient of 0.023/s acting over an altitude increment of 390 meters. This gust had a velocity increment of 9.0 m/s as determined from the angle-of-attack winds compared to 8.7 m/s from rawinsonde measurements. The wind component variation with altitude for the pitch plane was very similar to previous Saturn flights in both magnitude and direction (tail wind). Angles-of-attack and engine deflections were lower, however, due to the different trajectory flown by SA-3 and changed control gains.

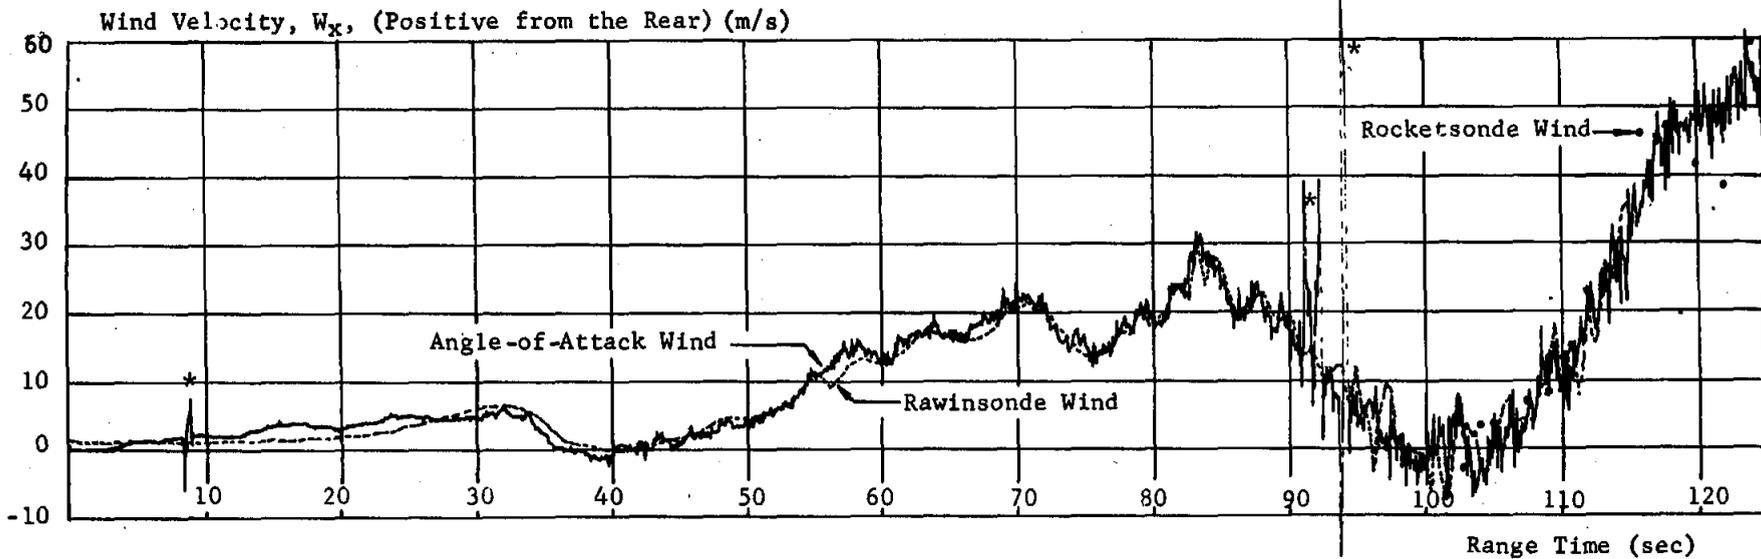
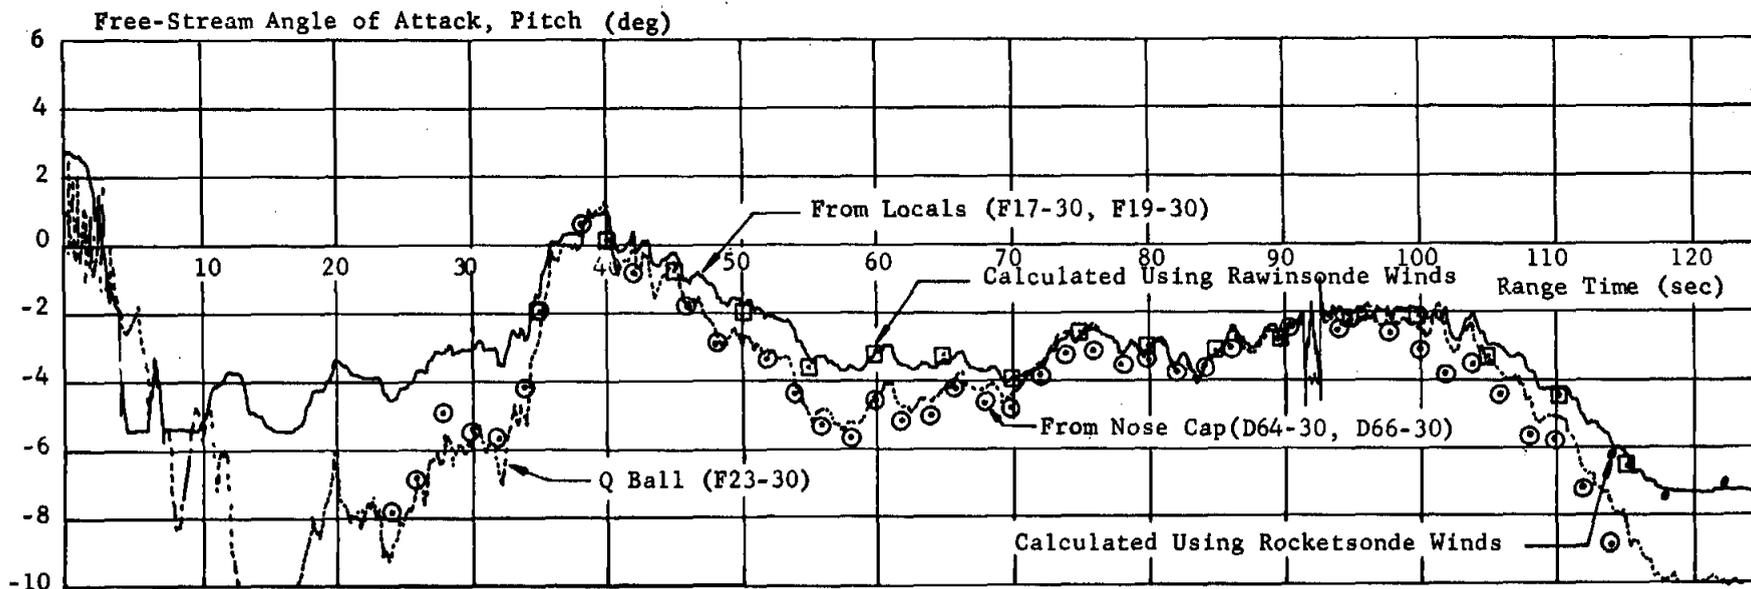
FIGURE 7-3 PITCH PLANE WIND COMPONENT AND FREE-STREAM ANGLE-OF-ATTACK

angle-of-attack winds. The angle-of-attack winds (solid line) were determined from attitude and angle-of-attack measurements made onboard the vehicle which were combined with trajectory angles and velocity components from tracking. Local angles-of-attack (U.S. Science meters) were used for this calculation after applying the appropriate correction for the upwash factor. Rawinsonde winds were obtained up to an altitude of 33.3 km (114.3 sec vehicle range time). Rocketsonde winds are shown as solid points in Figure 7-3. The angle-of-attack winds are considered questionable after 117 seconds.

The actual flight values are approximately 36% of the design values at 70 sec, which is near the maximum dynamic pressure region. The wind velocity at 70 sec was 20.1 m/s. All parameters were well below the design condition.

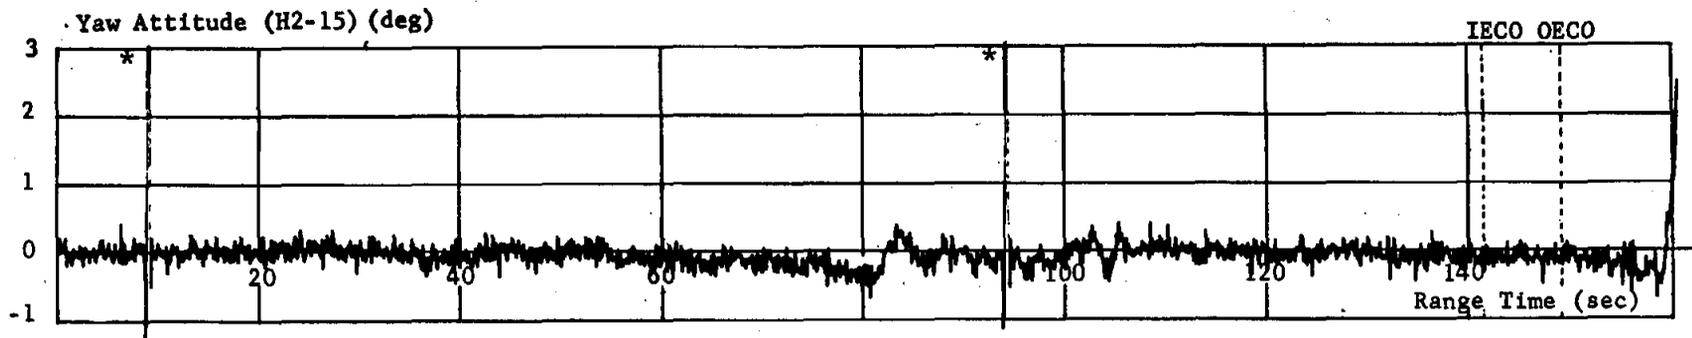
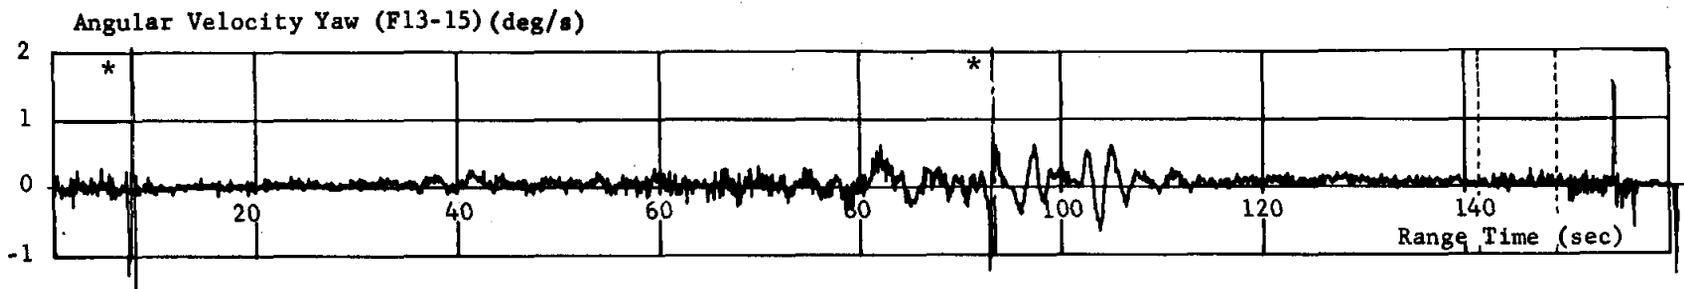
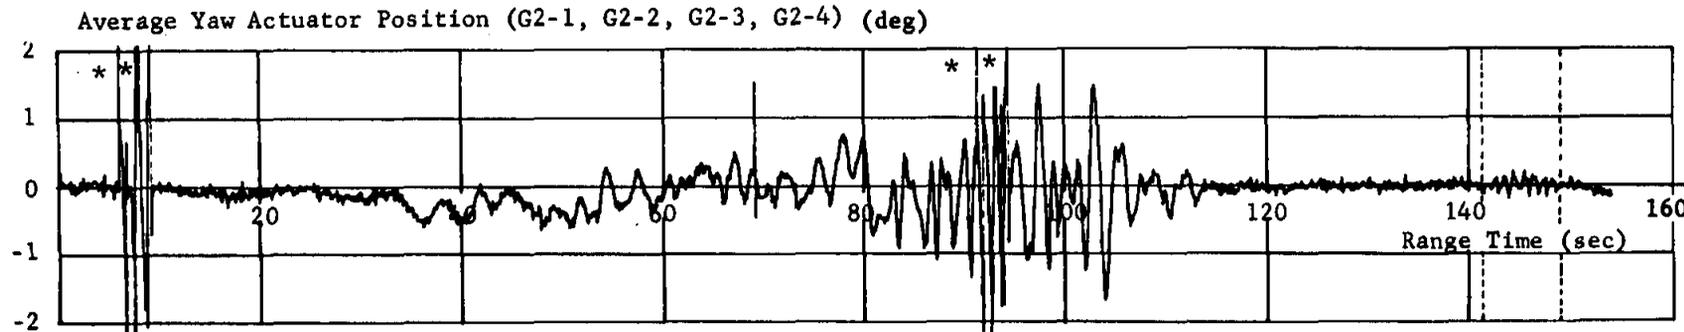
FIGURE 7-5 YAW ATTITUDE, ANGULAR VELOCITY AND AVERAGE ACTUATOR POSITION

Small yaw deviations were observed throughout the powered flight (Figure 7-5). Essentially all of these deviations were the results of winds. Comparatively large actuator movements occurred around 100 seconds. The largest actuator deflection was -1.7 deg at 103.7 sec as a result of a wind gradient of 0.02/s over an altitude increment of 670 meters. This wind gust had a velocity increment of 13.5 m/s as determined from angle-of-attack winds compared to 12.4 from rawinsonde winds.

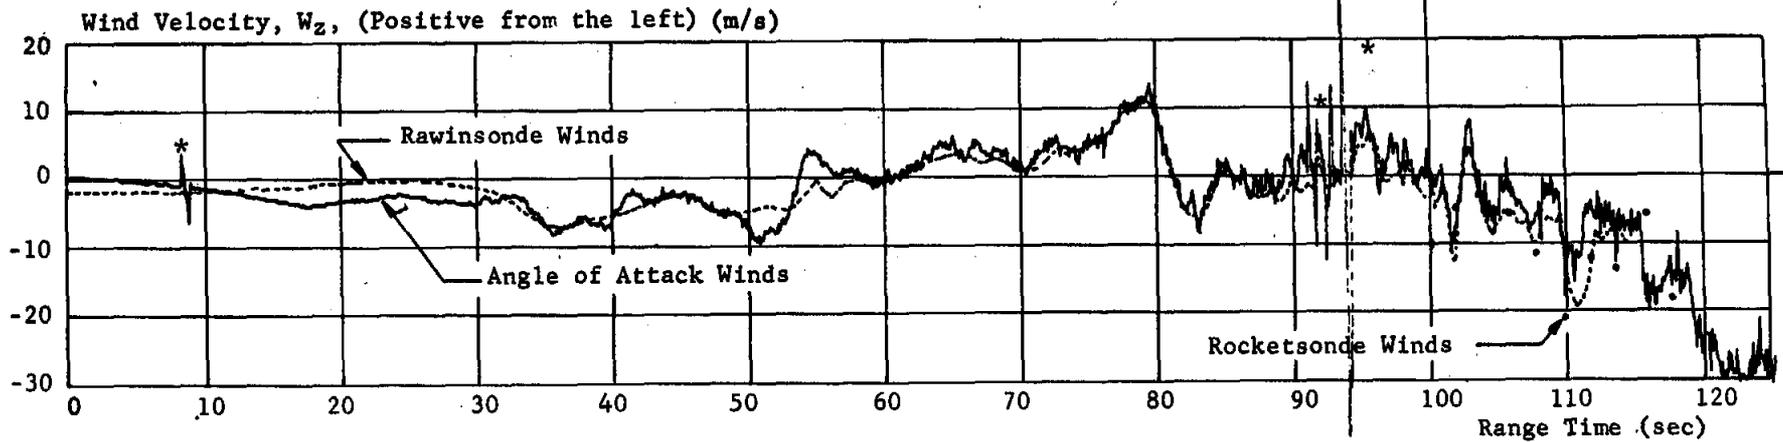
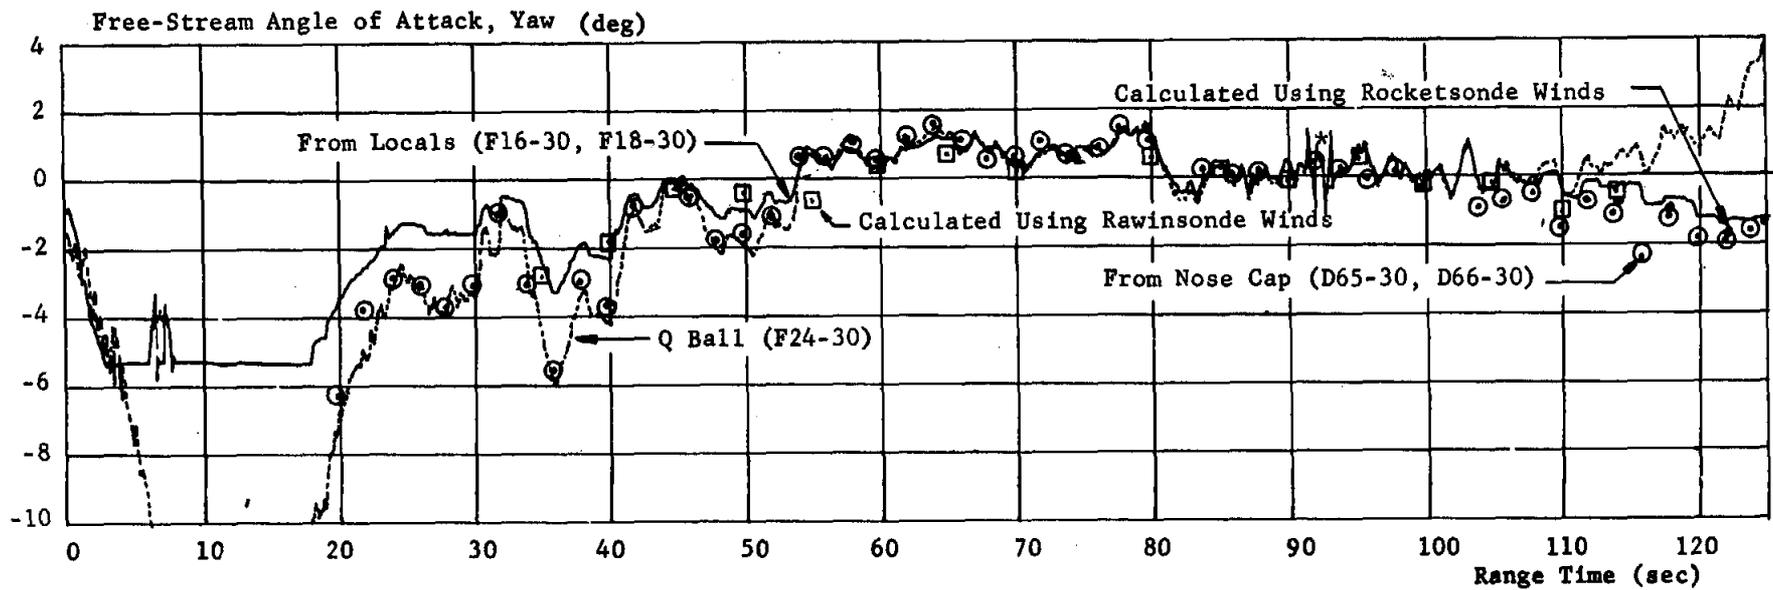
FIGURE 7-6 YAW PLANE WIND COMPONENT AND FREE-STREAM ANGLE-OF-ATTACK

Yaw plane wind components (Figure 7-6) were very light throughout the flight. The maximum yaw plane wind component was 13.2 m/s (from the left) at an altitude of 12.4 km (79.6 seconds). As in the pitch plane, good agreement existed between the angle-of-attack winds (solid lines) and the rawinsonde winds (dashed lines). Rocketsonde winds (solid points) were also in good agreement with both angle-of-attack and rawinsonde winds. The dynamic pressure at the point where the angle-of-attack winds appear to be unreliable (122 sec) was 0.026 kg/cm<sup>2</sup>.

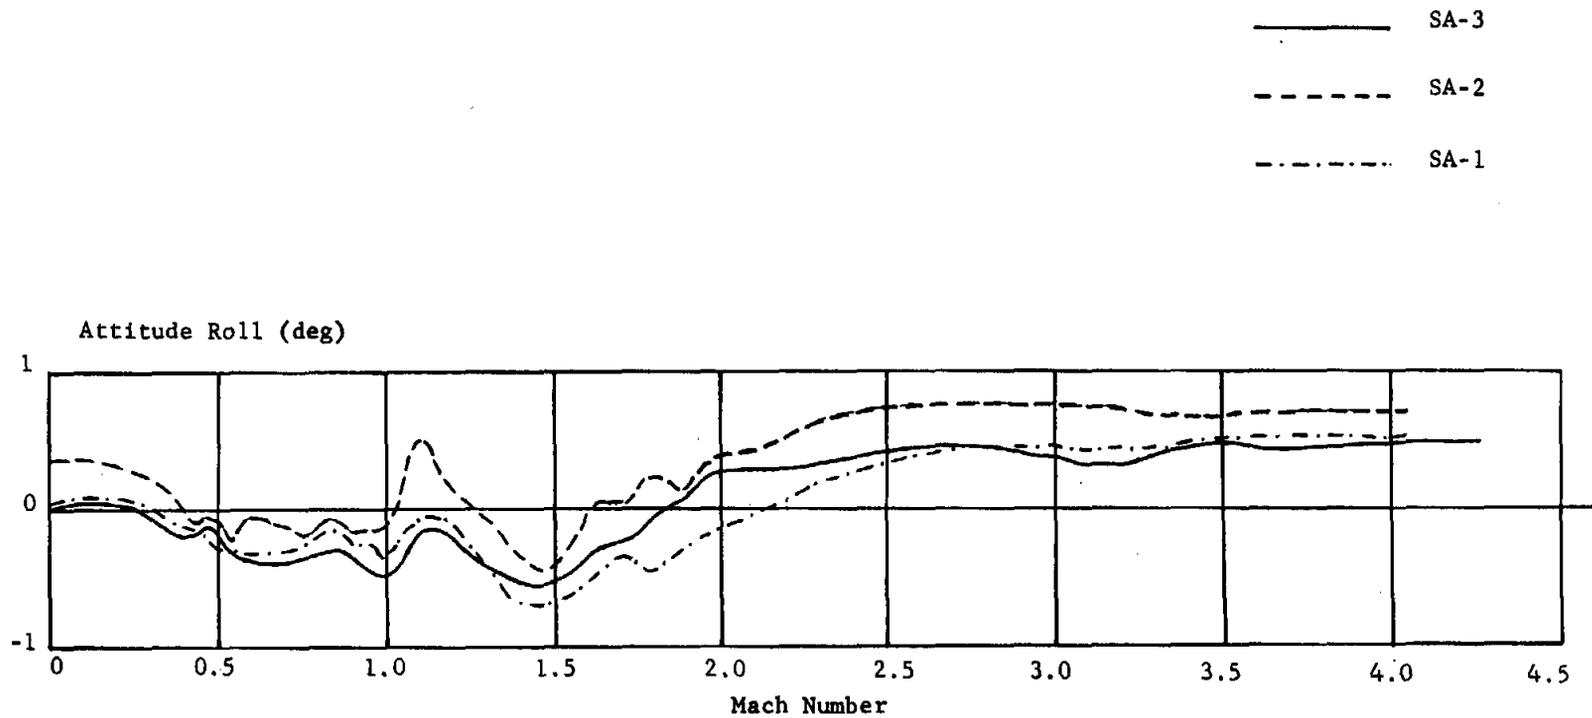
FIGURE 7-8 COMPARISON OF ROLL ANGLE DEVIATIONS FOR SA-1, SA-2 AND SA-3

SA-1 and SA-2 followed the same trajectory and had similar characteristic roll angle time histories. SA-3 flew a different trajectory, and the time history of the roll angle for SA-3 was also somewhat different from that of the first two vehicles. However, if the roll attitudes for the three flights are plotted together as a function of Mach number, (Figure 7-8) the trend is almost identical and indicates a close correlation. The increase in roll (in the CW direction) after Mach 1.5 can be correlated with the longitudinal acceleration. The variations in roll between 60 and 90 sec (prior to Mach 1.5) are most closely correlated with Mach number, indicating a possible aerodynamic effect.

The roll after Mach 1.5 appears to be more likely an inertial effect. This is also very apparent in the level changes in the roll bias after each cutoff. One possible explanation of this is that the basic trend to roll in the CW direction may be associated with a softness in the servo system and structure associated with the actuators. The centers of gravity of the engines are offset in the proper direction such that, coupled with the softness and the inertial load, it could cause an angular misalignment of the thrust vectors. The actuator loads, as measured by the actuator differential pressures (Figure 7-13), are consistent with this hypothesis.

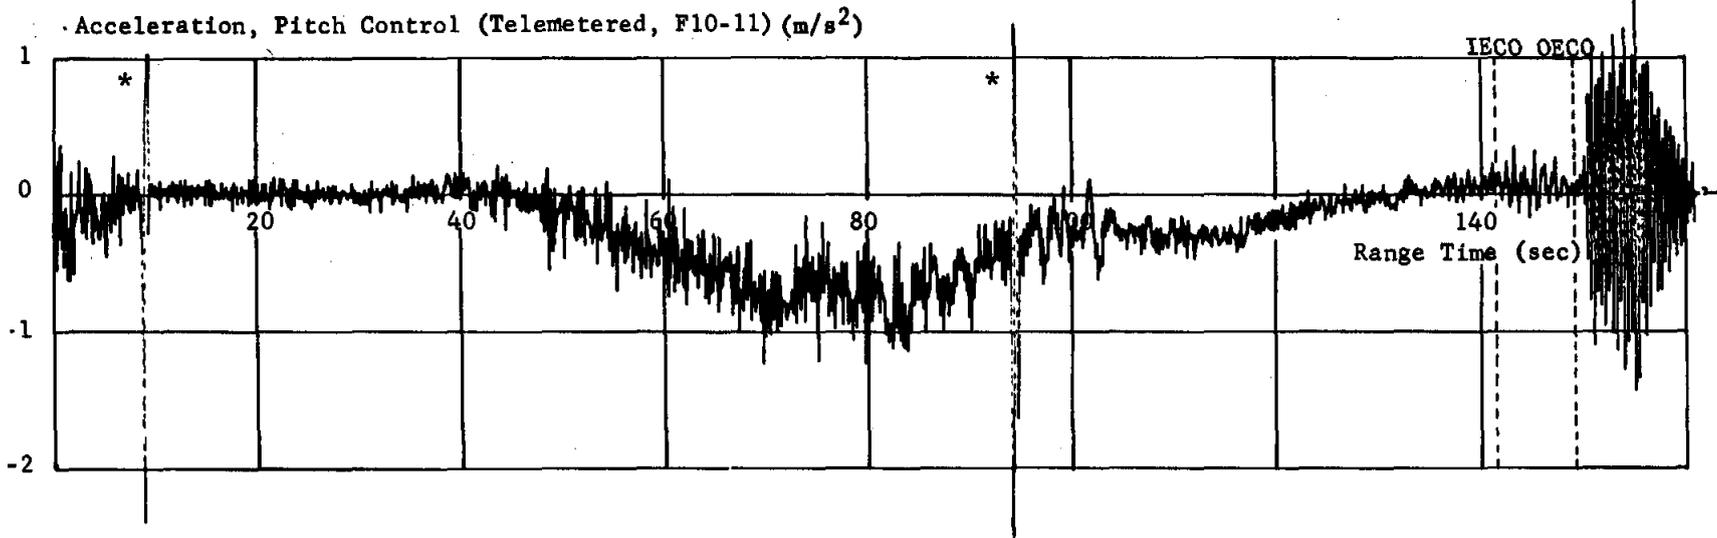
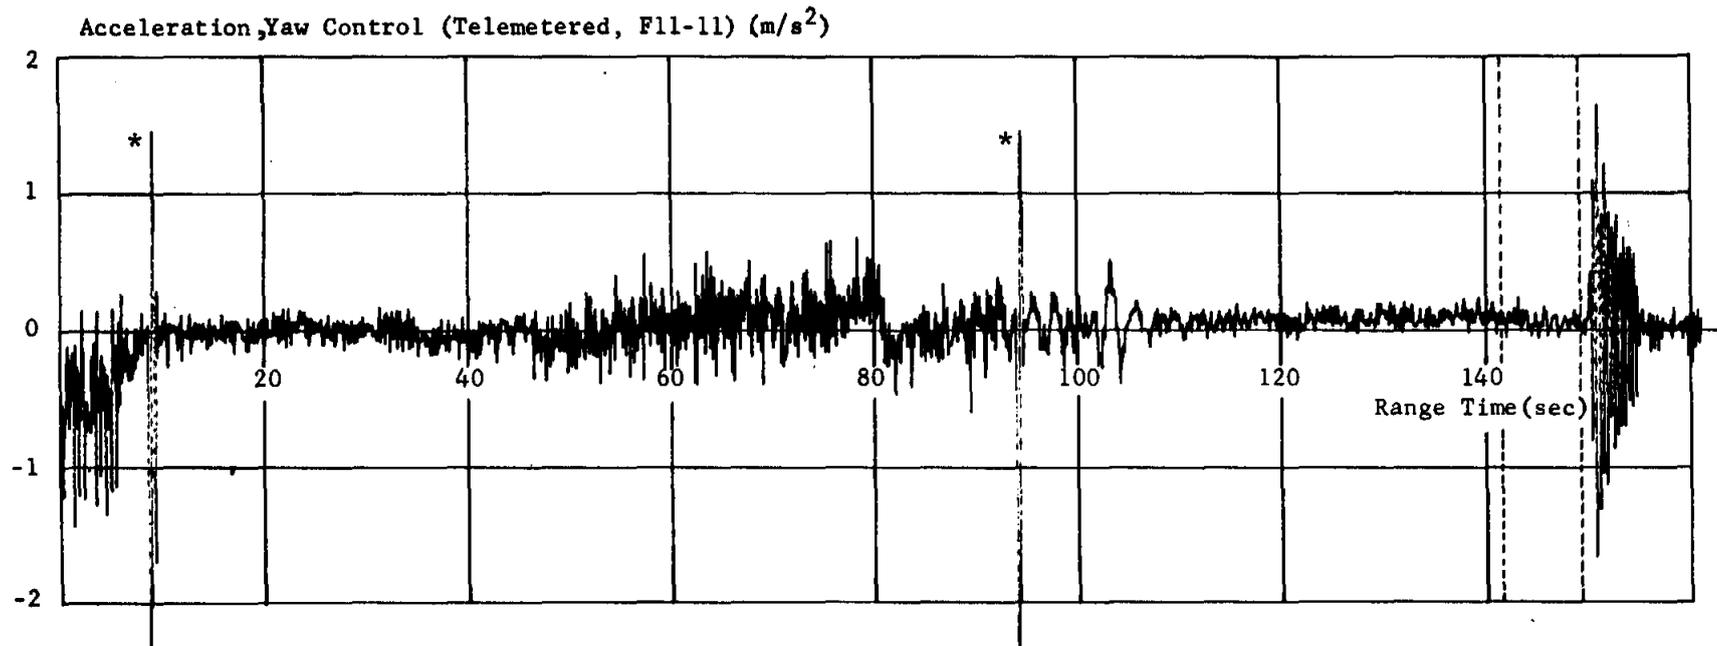
FIGURE 7-10 PITCH AND YAW CONTROL ACCELERATIONS

Two Statham control accelerometers (pitch and yaw) were flown for operational study purposes for the first time on SA-3. The telemetered accelerations (Figure 7-10) show proper operation of the equipment during flight. These would have been acceptable for closed loop operation in the flight control system. A comparison made between the telemetered acceleration and that calculated from independent flight measurements gives satisfactory agreement, less than  $0.2 \text{ m/s}^2$ , which is within the error limits of the reduced data used in the comparison. A considerable amount of high frequency (approximately 10 to 15 cps) oscillations appear on the measurements, but they are less than were experienced from the Edcliff accelerometers flown in the same location on SA-1 and SA-2. Statham type control accelerometers will be flown in closed loop control on SA-4, in place of the local angle-of-attack transducers.

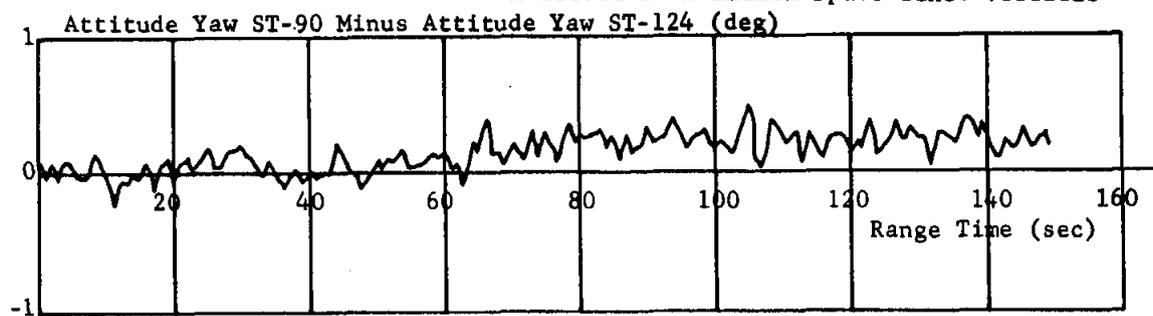
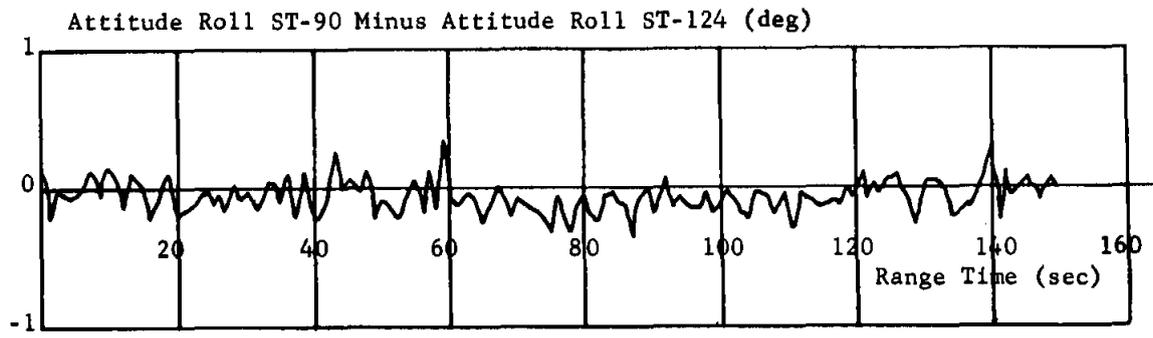
FIGURE 7.15 ATTITUDE DIFFERENCES BETWEEN ST-90 AND ST-124P

mentioned in section 8.3.3. The additional small differences are felt to be due to excess backlash in the servo system gear trains in the ST-124P and telemetry and data reduction errors. The much larger systematic difference between the pitch attitude angles is due to an impedance mismatch in the ST-124P resolver chain. This pitch angular error ( $\phi_e$ ) is a function of the impedance mismatch and the sine of twice the resolved angle (i.e.  $\phi_e = M \sin 2X$ ).  $X$  is the tilt angle of the ST-124P outer pitch resolver. The dashed line in Figure 7-15 shows the remaining difference in the pitch angles after a correction for a 1.3  $\Omega$  (approximately 0.3%) impedance mismatch error has been made.

To substantiate the mismatch assumption, the platform for SA-4 was tested and found to have a similar error build-up as the tilt program was run in. The error for a tilt angle of 44 deg amounted to 1.75 degrees. This will be reduced to less than 0.25 deg by balancing out the major portion of the mismatch before the platform is flown.

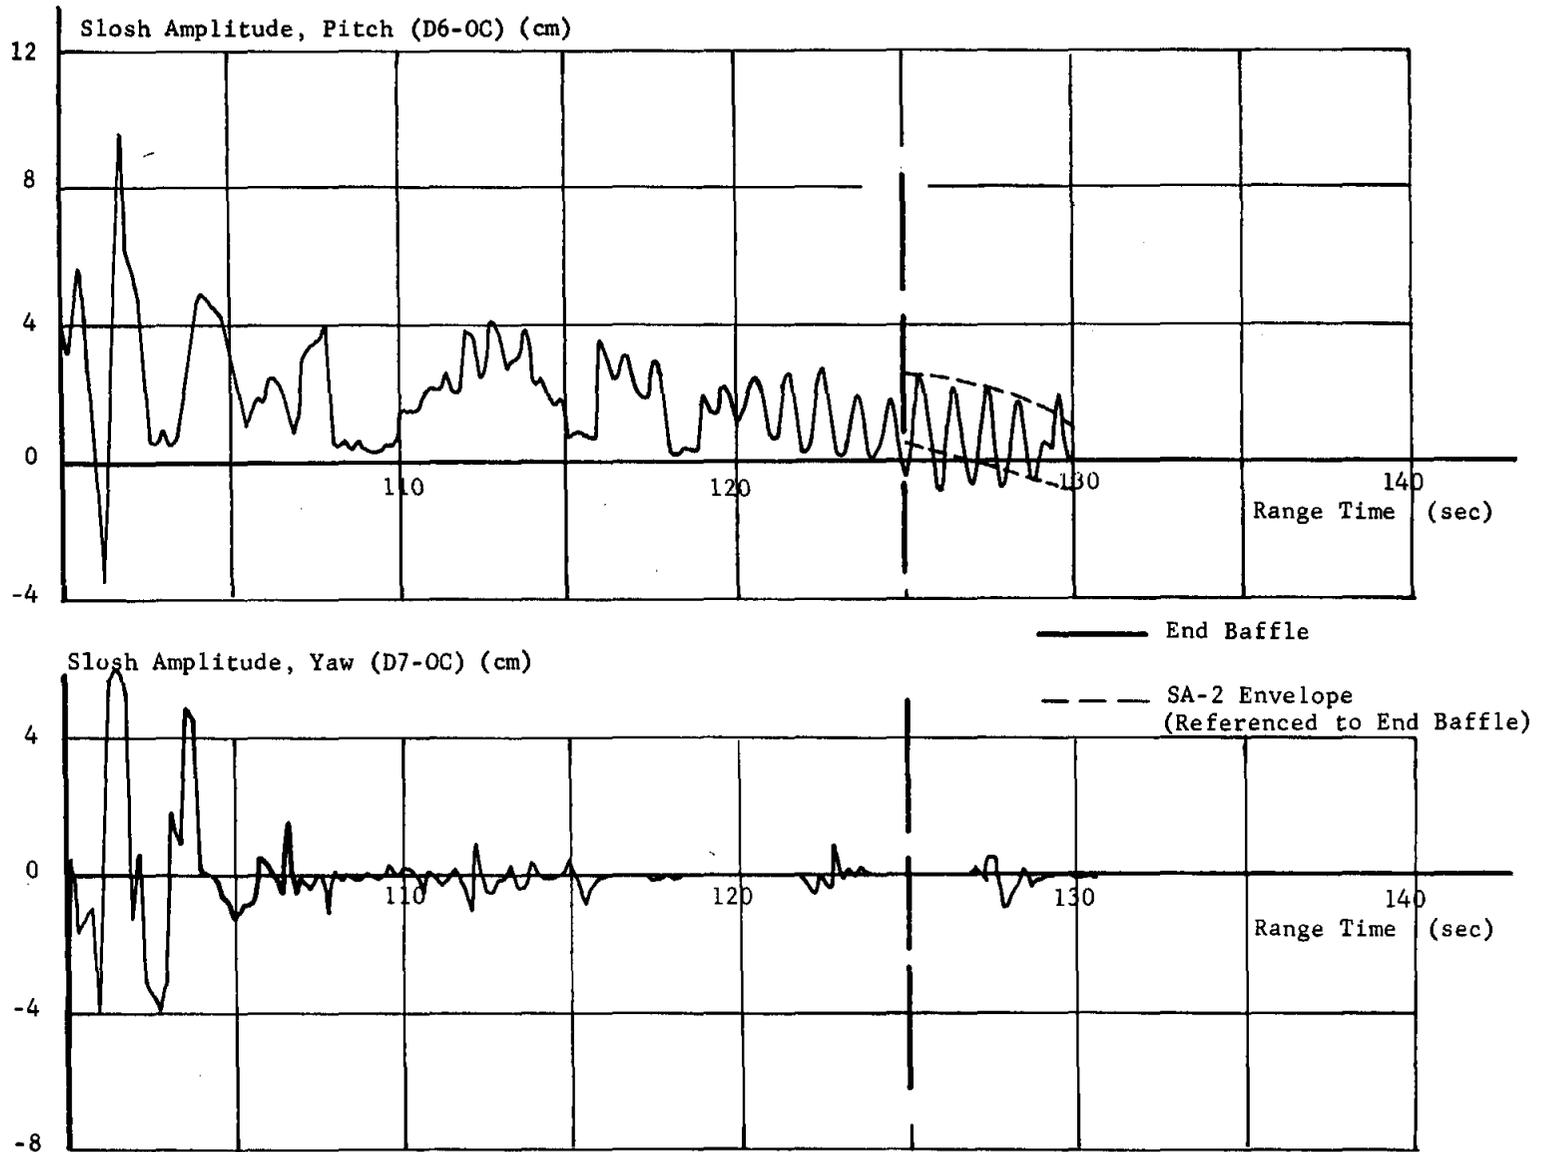
FIGURE 7-16 CENTER LOX TANK TELEMETERED SLOSHING AMPLITUDES AFTER 100 SECONDS

The most noticeable sloshing near the end of powered flight was detected on measurement D6-0C in the center tank. A pronounced regular oscillation started around 120 sec, which was before the propellant surface went below the baffles (Figure 7-16). The amplitude amounted to only about  $\pm 1$  cm up to the time the fluid surface went below the slosh probe and the measurement ended. The dashed lines in Figure 7-16 show the envelope of the slosh amplitude observed in the center tank on SA-2. This has been referenced to the location of the end of the baffles, since the time history of the two flights was different due to the propellant loading differences. The sloshing in the center tank was similar in magnitude on SA-2 and SA-3. However, it appeared that sloshing started somewhat earlier on SA-3. Also, the vehicle was driven more at the sloshing frequency as mentioned previously, than SA-2.

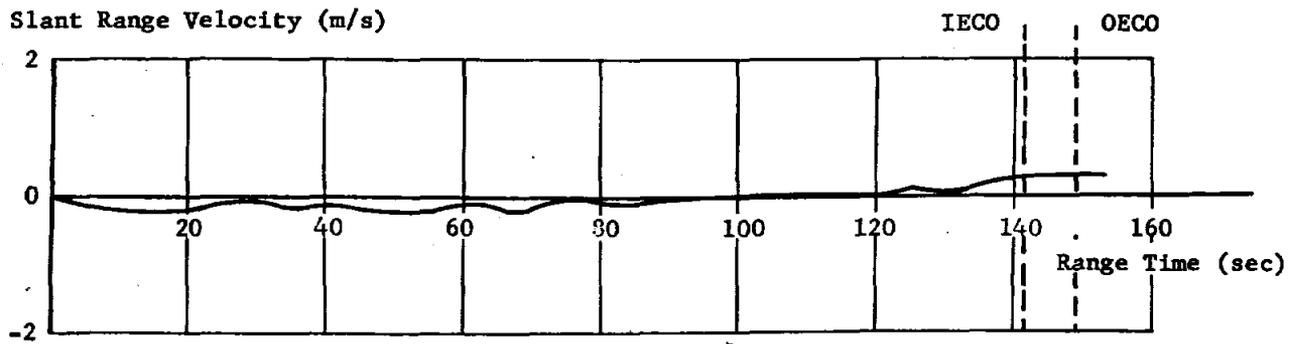
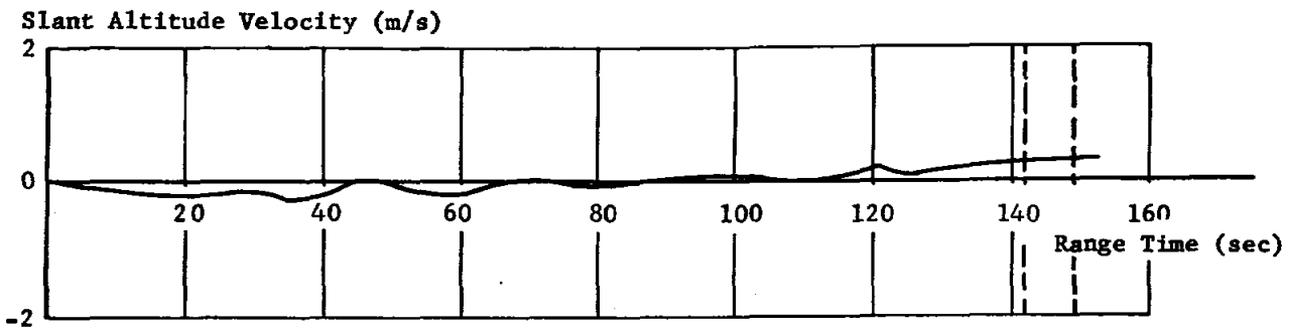
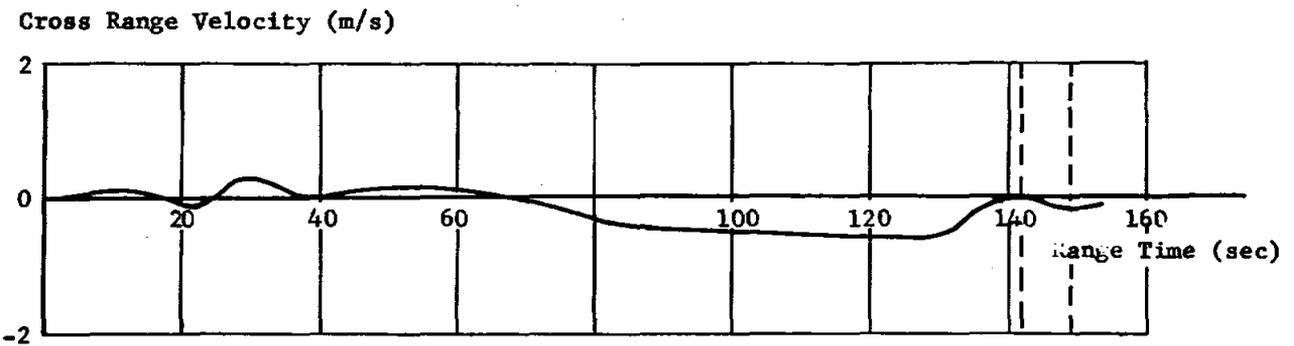
FIGURE 8-1 GUIDANCE VELOCITY COMPARISON (ST-90)  
(TELEMETERED-CALCULATED)

The errors presented in Figures 8-1 and 8-3 include errors in tracking and data reduction as well as guidance hardware errors. ST-90 guidance intelligence errors, shown in Figure 8-1, are within the data noise level and one sigma hardware errors.

The outputs of the slant range accelerometer were compared with corresponding values computed from earth-fixed trajectory data assuming ideal alignments of the platform and accelerometers. These differences are plotted versus time in the upper portion of Figure 8-1. The errors oscillate around zero for the entire powered flight. The small errors observed are the results of errors in the data compared and hardware errors within established one sigma values.

Differences between the telemetered and calculated ST-90 cross range velocities are plotted versus time in the lower portion of Figure 8-1. The differences oscillate around the zero reference until after 70 seconds. From this time the differences increase to about -0.5 m/s at 90 sec and remain practically constant to 130 seconds. The differences go to essentially zero by 140 seconds. The error profile presents no definite trend and the differences are probably due to bias shifts in tracking data rather than the ST-90 guidance equipment. However, the cross range velocity errors are within the usual noise level of data compared and the one sigma errors of the guidance hardware.

The differences between telemetered and calculated slant altitude velocities are plotted versus time in the middle portion of Figure 8-1. The differences oscillate around the zero reference within  $\pm 0.3$  m/s, indicating very good agreement of the data compared.
