MPR-SAT-63-1  
January 8, 1963

SATURN SA-3 FLIGHT EVALUATION

VOLUME I

By Saturn Flight Evaluation Working Group

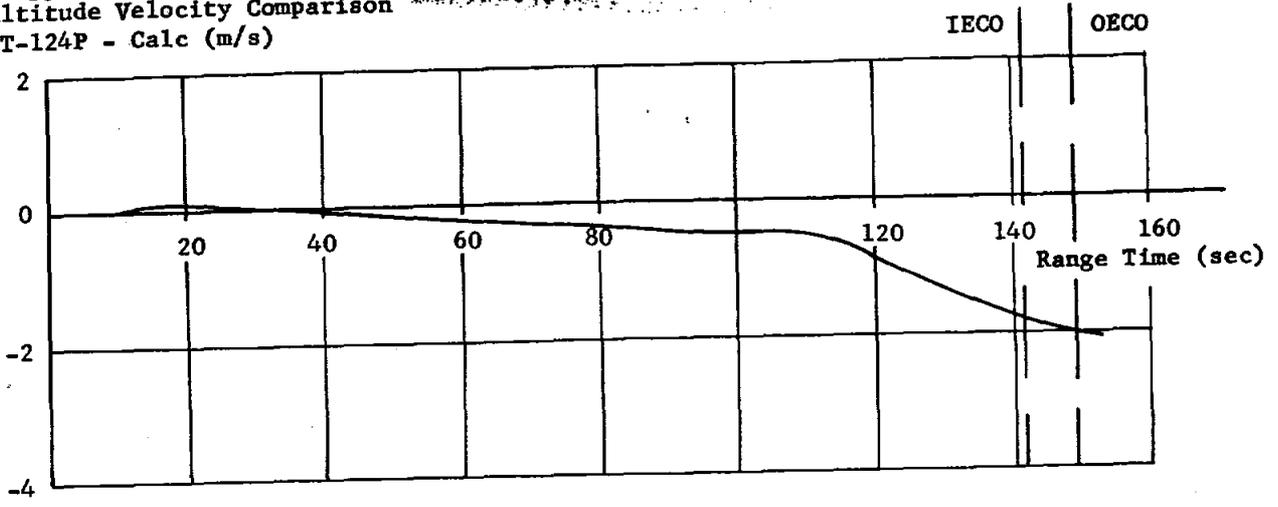
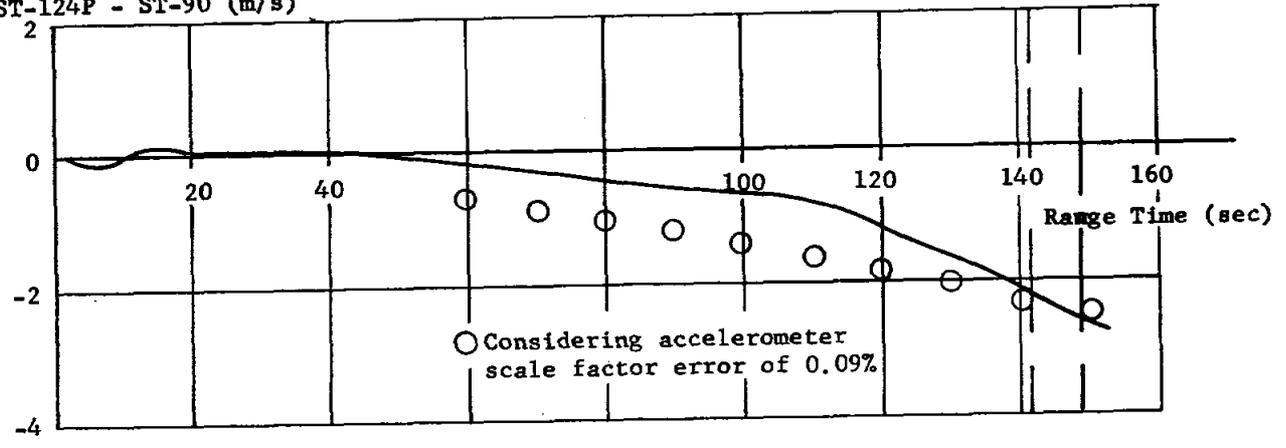
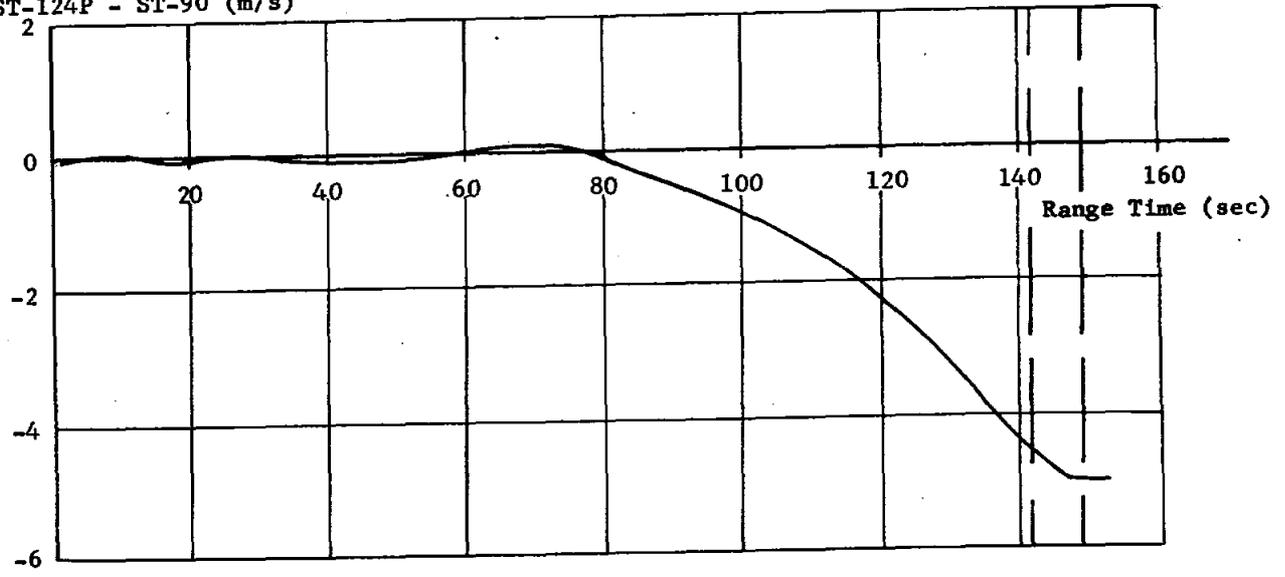
FIGURE 8-3 GUIDANCE COMPARISONS, ST-124P GUIDANCE SYSTEM

The upper portion of Figure 8-3 presents differences between the telemetered and calculated altitude velocities. The differences are essentially zero until about 40 seconds. From this time, the differences increase until at end of thrust the value is about -2.1 m/s.

A similar comparison was made between the outputs of the vertical accelerometer (ST-124P) and corresponding values determined from the slant range and slant altitude accelerometers carried on the ST-90 platform. This comparison is presented in the middle portion of Figure 8-3. Both comparisons indicate an error of approximately 2.5 m/s in the altitude velocity telemetered from the ST-124P system.

A scale factor error of about -0.1% was noted in the vertical accelerometer about 90 min prior to launch. An error of this magnitude

would produce the observed velocity error. After correcting for the scale factor error, the altitude velocities from the two guidance systems are in agreement, indicating maintenance of proper orientation of the ST-124P platform about its Z-axis.

The circled points shown in Figure 8-3 represent the velocity difference for an accelerometer scale factor error of 0.09%.

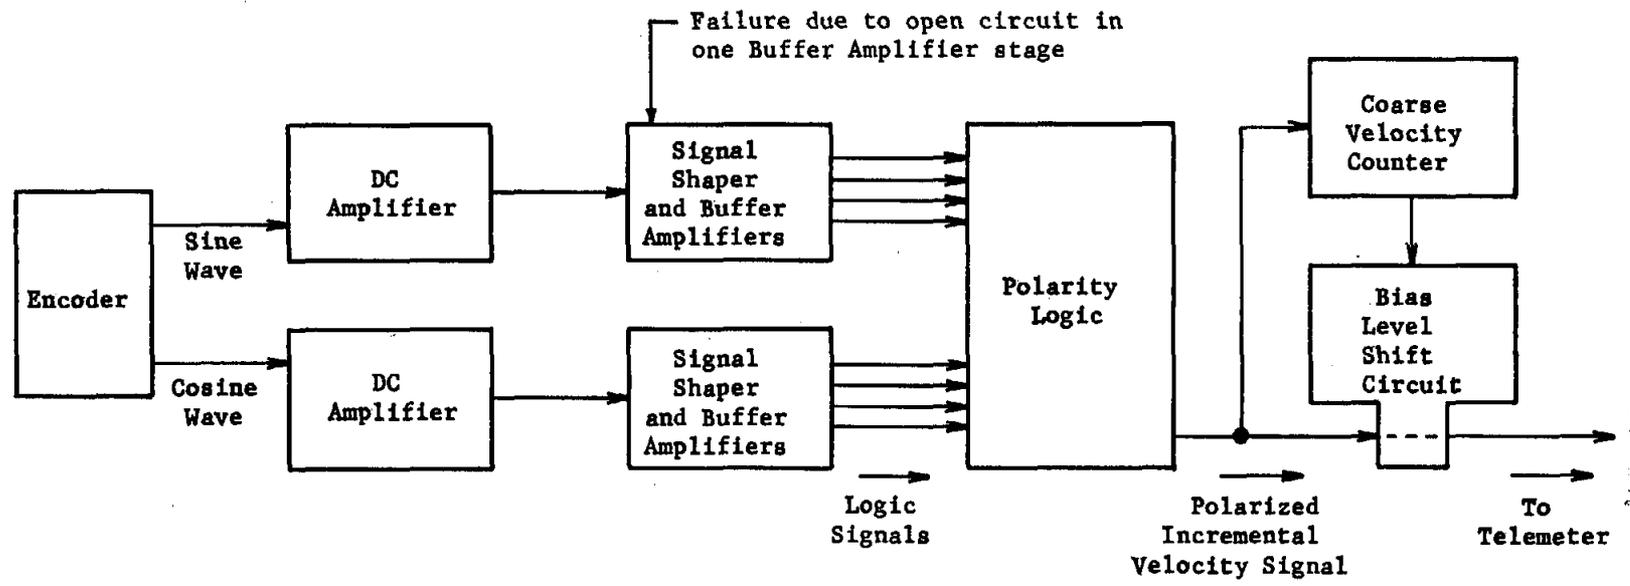
FIGURE 8-5 SIMPLIFIED SCHEMATIC OF CROSS RANGE SIGNAL PROCESSOR

Two Guidance Signal Processor Repeaters were flown on SA-3, one for each stabilized platform. The processor for the ST-90 system operated satisfactorily throughout the flight; the second unit, for the ST-124P system, had a failure in a buffer amplifier stage causing loss of one of the DC logic signals used in sensing the polarity of the cross range velocity increments. This malfunction occurred early in the countdown. A second disturbance in this processor occurred intermittently in both channels during the time period from 113 to 125 seconds. The disturbance is believed to be due to voltage transients on the processor B+ line.

Ground recording and inflight telemetry records showed a disturbed condition of the ST-124P cross range velocity system, which appeared to indicate that the accelerometer was wandering randomly. This has been shown to be incorrect after a detailed study of the ground and inflight records, the logic network of the signal processor, and the 65 cps oscillation observed in the accelerometer servo loop.

Oscillation of the accelerometer system would normally result in both positive and negative incremental velocity pulses, which cancel each other except for actual velocity change. However, with a loss of one DC logic signal used in sensing the polarity of the velocity increment, the output would be a continuous pulse pattern as shown in pattern 1 of Figure 8-4. As the system changes position, intermediate pulse patterns occur as shown in the even numbered patterns of Figure 8-4. When the pulse pattern on the telemetry record changes from one pattern to a second distinct pattern, a velocity change of 0.1 m/s has occurred. The pulse patterns result from a combination of three conditions:

1. A small true acceleration.
2. Accelerometer servo loop oscillation.
3. Loss of one logic signal in the signal processor.

It was concluded from this study that the loss of one DC logic signal input to the rotation sensor logic circuits, combined with the 65 cps modulation of the true accelerometer output, could produce the patterns of incremental velocity pulses observed on the telemetry and ground recordings (see Figures 8-4 and 8-5). Laboratory tests confirmed the above conclusion. The pulse pattern sequences were used to reduce the actual telemetered cross range velocity from the ST-124P system. The second disturbance to the signal processor occurred intermittently from 113 to 125 sec range time and was characterized by improper shifting of the bias voltage for the coarse velocity indication in both cross range altitude channels. Short term voltage transients of fairly large amplitude on the B+ line are believed to be the source of this extraneous switching of the bias flip-flop. The source of the transients could not be determined, but could have originated either on the D21 buss, in the static inverter, or in the signal processor power supply.

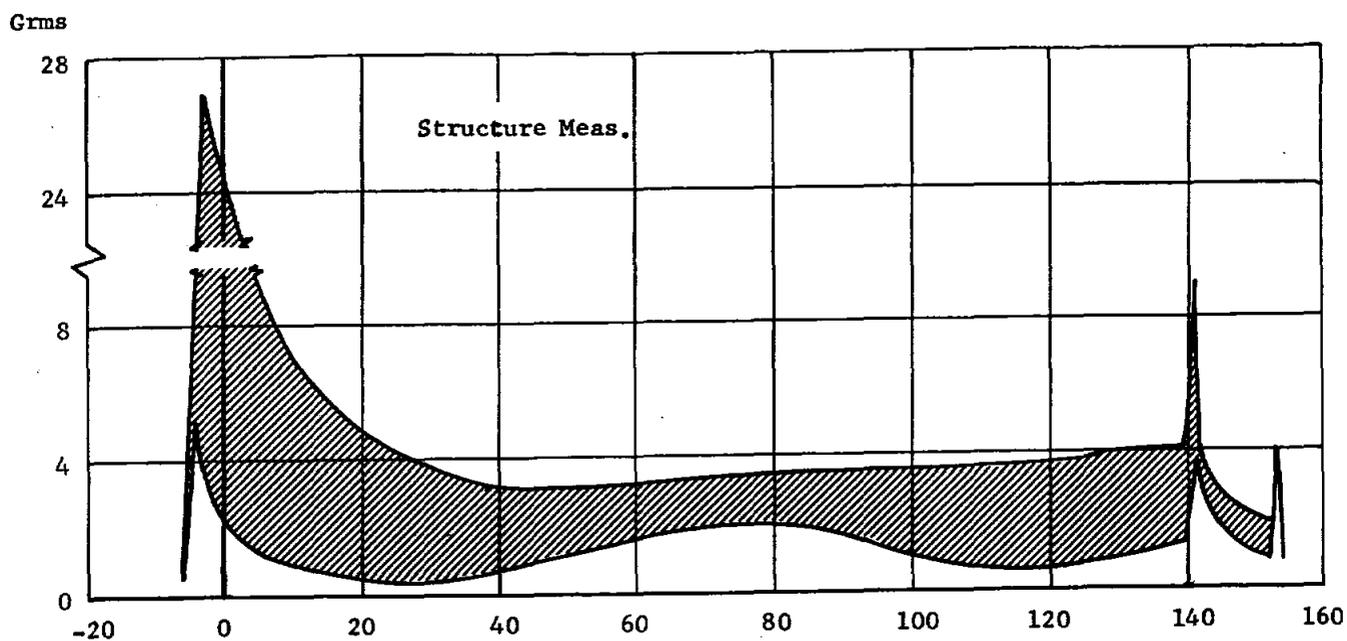
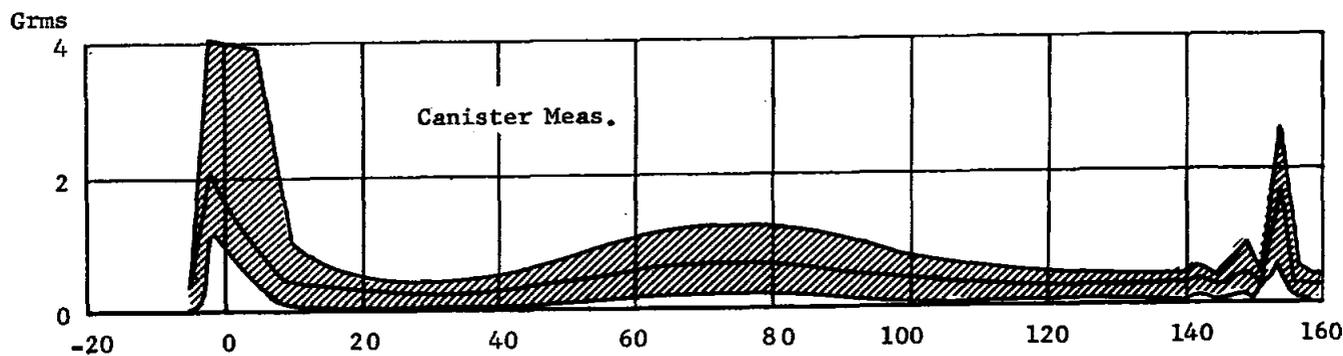
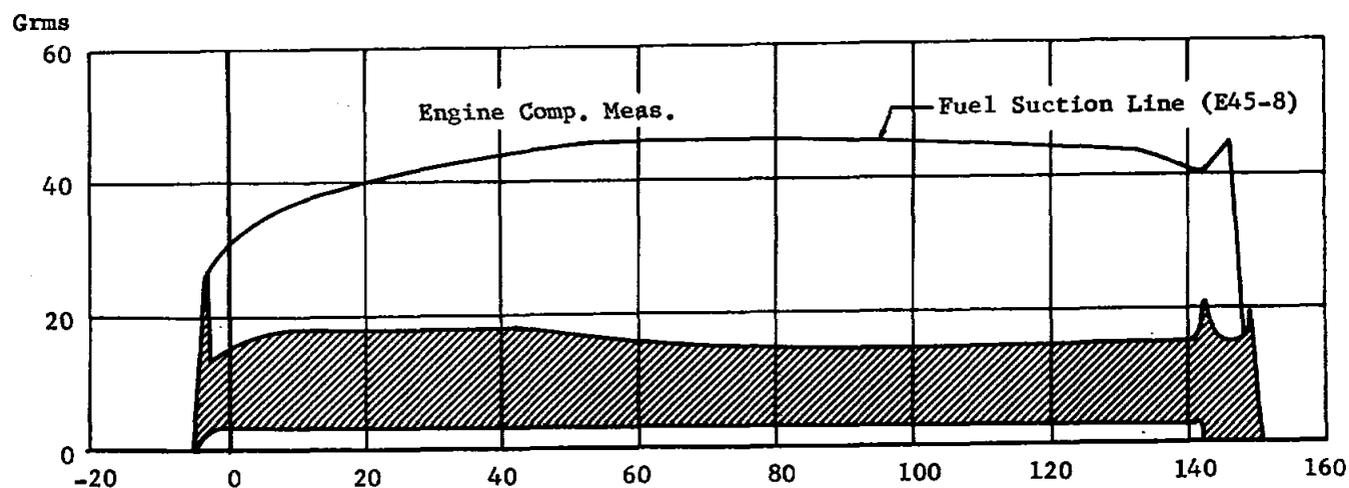
FIGURE 10-9 VIBRATION ENVELOPE OF STRUCTURE,  
CANISTER AND ENGINE COMPARTMENT MEASUREMENTS

All engine vibration data from SA-3 flight compared very well to SA-1 and SA-2 data except measurement E45-8 (fuel suction line long't), which was about twice as high on SA-3 flight as compared to SA-2 flight. However, no evidence of structural failure was indicated in this area. An investigation is being made to determine the cause of these high levels. Because of the high levels indicated, measurement E45-8 was not included in the maximum and minimum acceleration time histories as shown in the lower part of Figure 10-9. However, it is felt that the measurement is valid.

The center part of Figure 10-9 presents an envelope of the RMS acceleration time histories obtained from the canister area. This envelope does not reflect erratic transients which occurred on some of

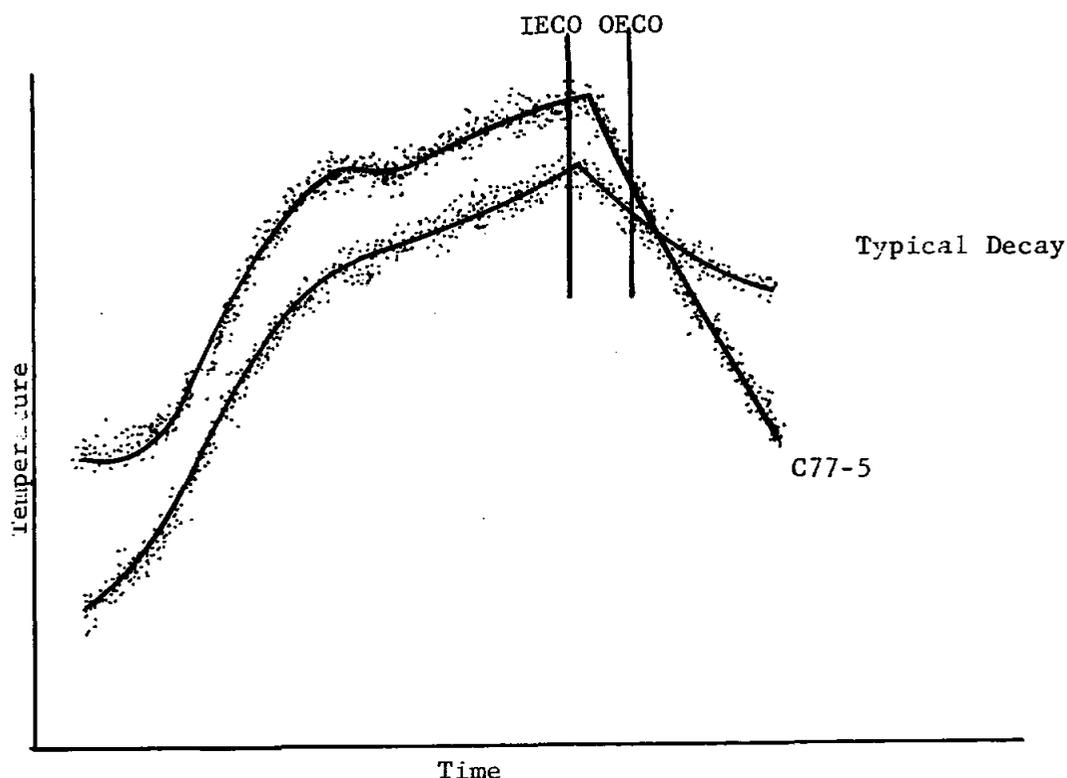
COMPARISON OF CUTOFF DECAY FOR C77-5 WITH A TYPICAL DECAY

This particular calorimeter, even though it showed almost identical efficiency as calorimeters C76-3 and C63-1 in laboratory calibration, had a loss after cutoff (based on the temperature-time history) of almost twice the rate encountered on C76-3, C63-1, or on previous flights' total calorimeter measurements (see illustration on the following page).

At this time no explanation as to the cause of this rapid temperature decay is available, but preliminary evaluation indicates the following possibilities: 1) a difference in the heating and cooling cycles possibly exists, whereby the correction factor obtained after cutoff is possibly not valid for the entire flight, 2) possible conduction losses during flight higher than indicated by the laboratory calibration method, and 3) a possibility of a convective cooling source hitting the calorimeter surface at cutoff could exist.
